DECK AUDIT

CONDOMINIUM CORPORATION

CONDOMINIUM PLAN No. [REDACTED]

May 2015

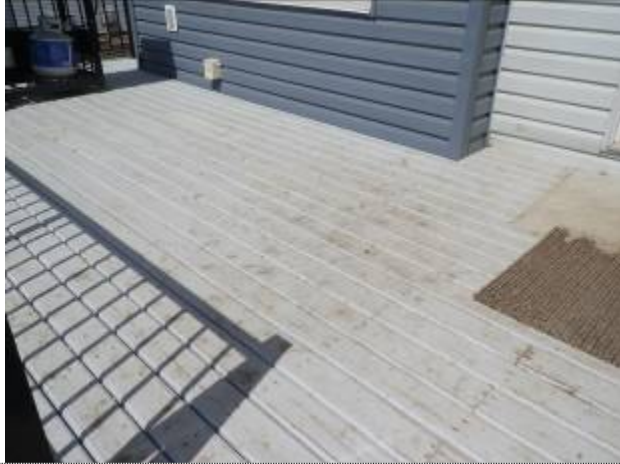
1
Minor deterioration at joints

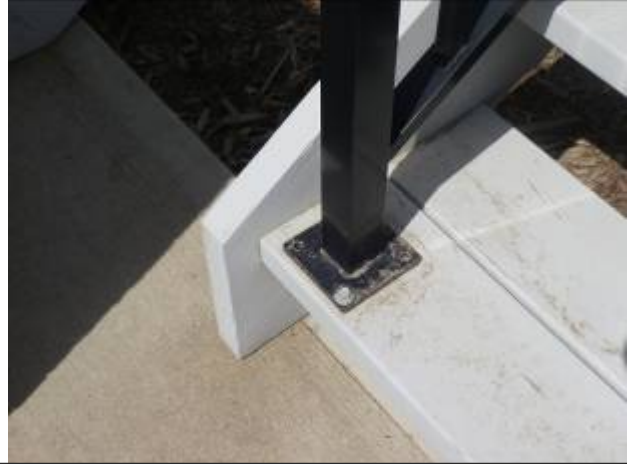
3
Missing bolts in railing

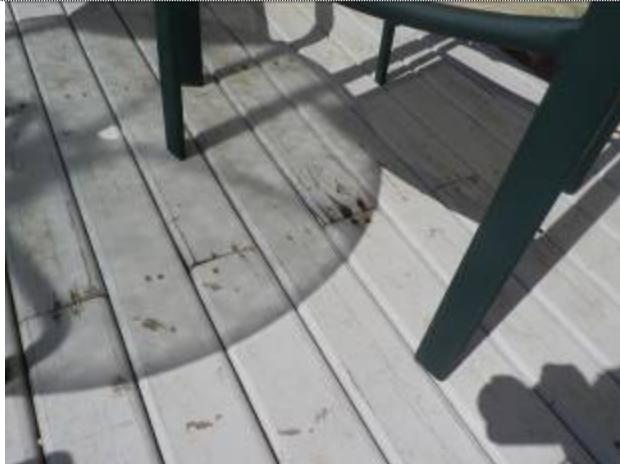
5
Significant deterioration at joints & screw penetrations

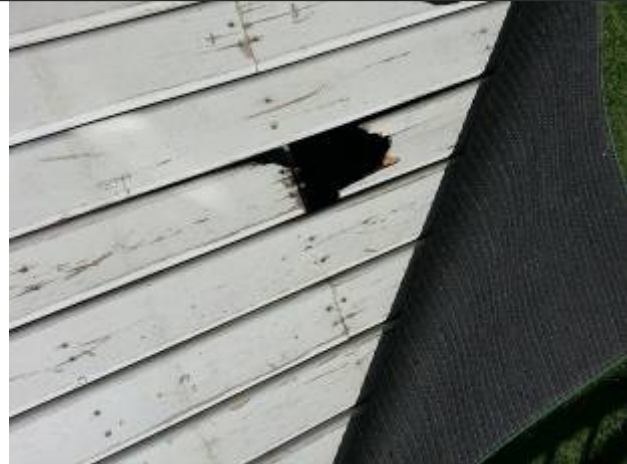
7
Significant deterioration and rot of deck boards

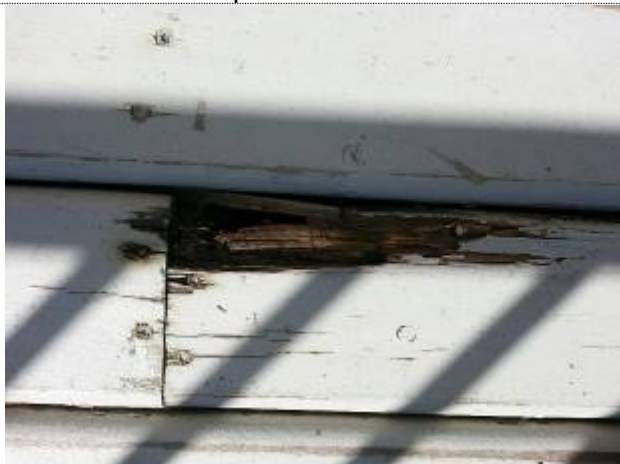
7
Deterioration of wood

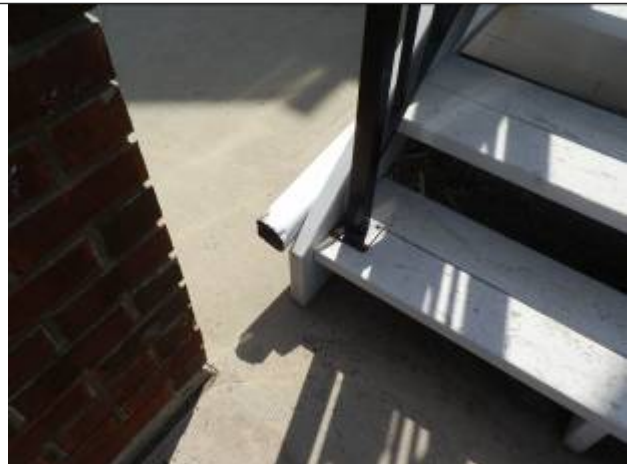
8
Downspout terminating against stringer

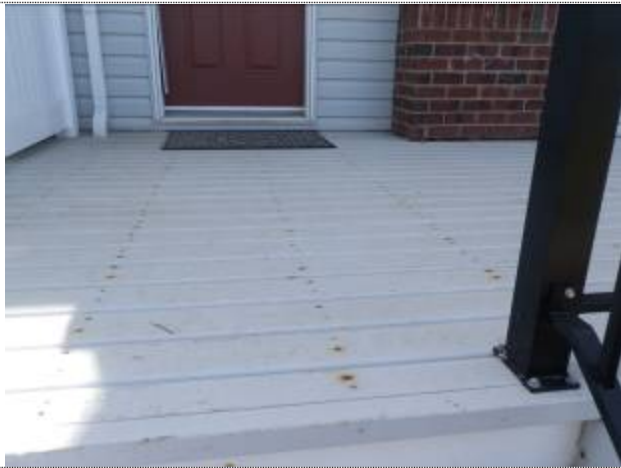
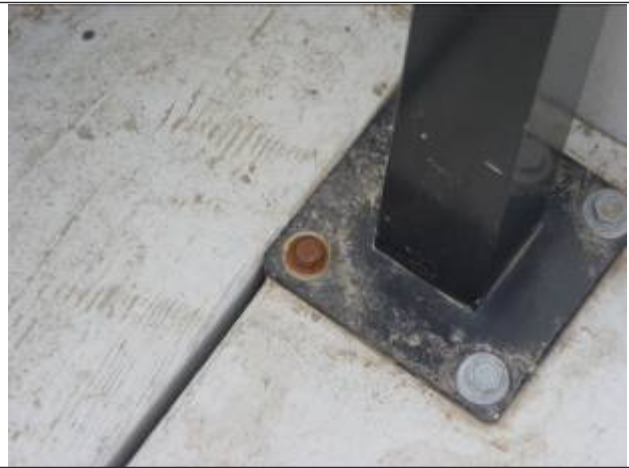
8
Rusted screws and bolts

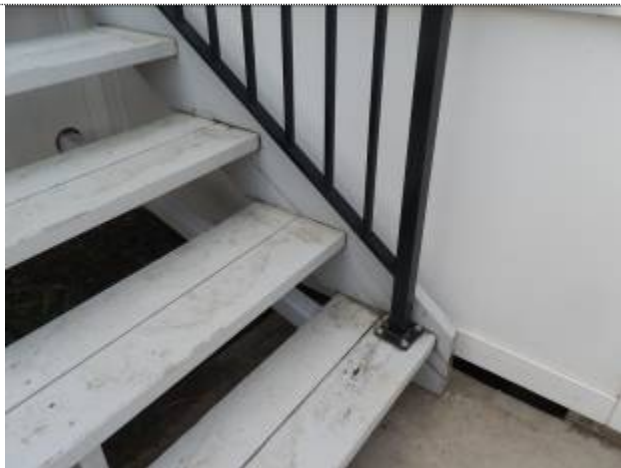
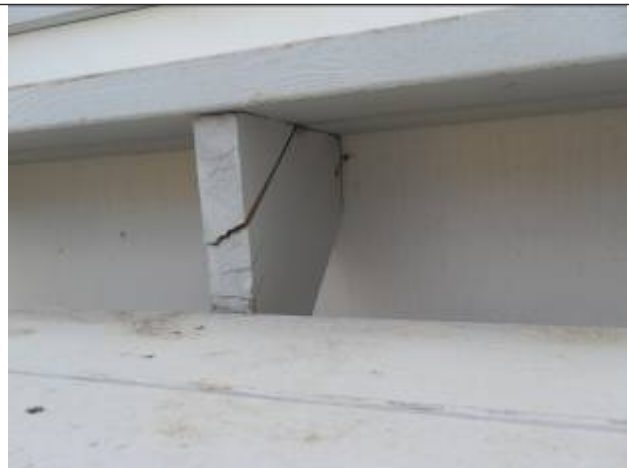
10
Damaged stringers

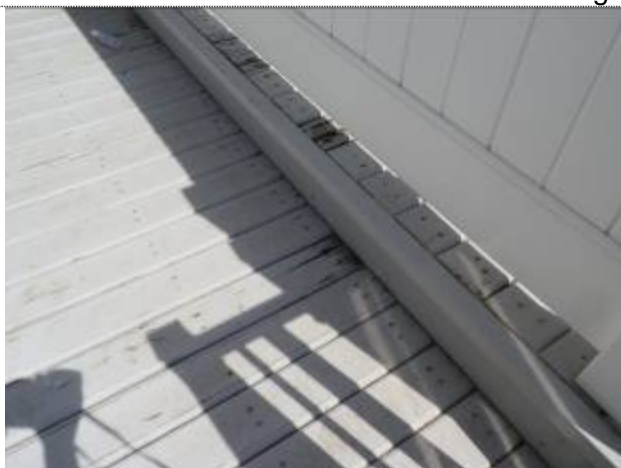
9 & 11
Deterioration at end of deck boards at screw penetrations

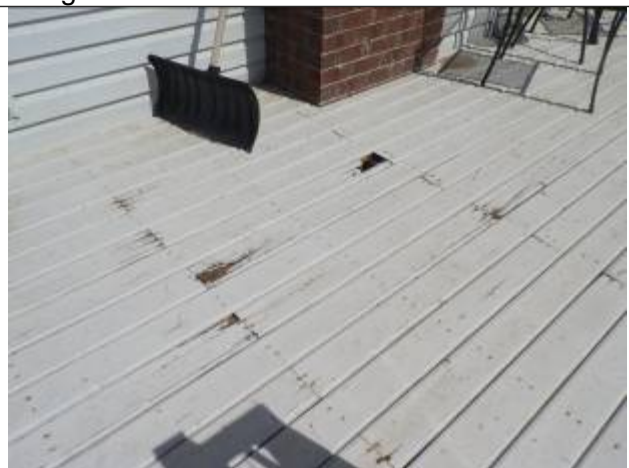
11
Rotted wood

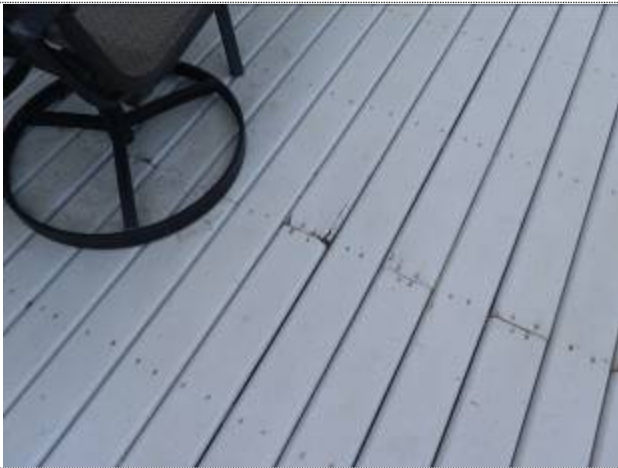
12
Deterioration at joints where screws penetrate

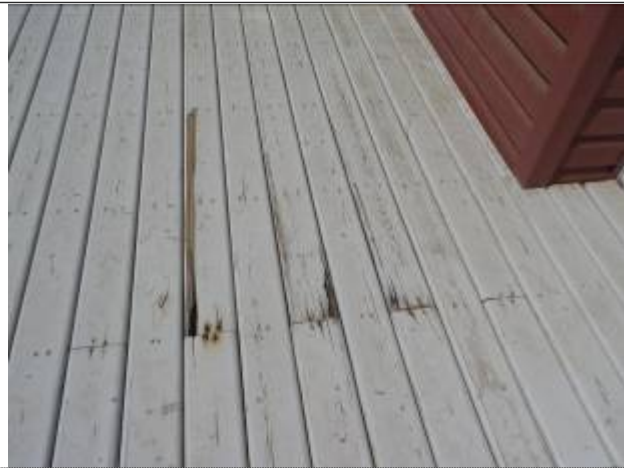
17
Deterioration at joints where screws penetrate
Gouge in decking

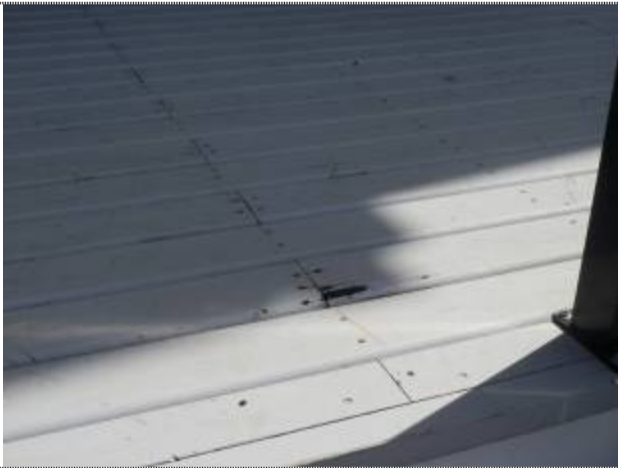
20
Deterioration at joint

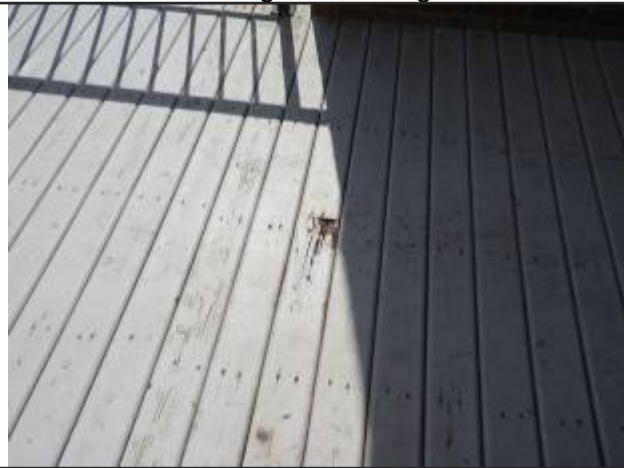
21
Deterioration in decking

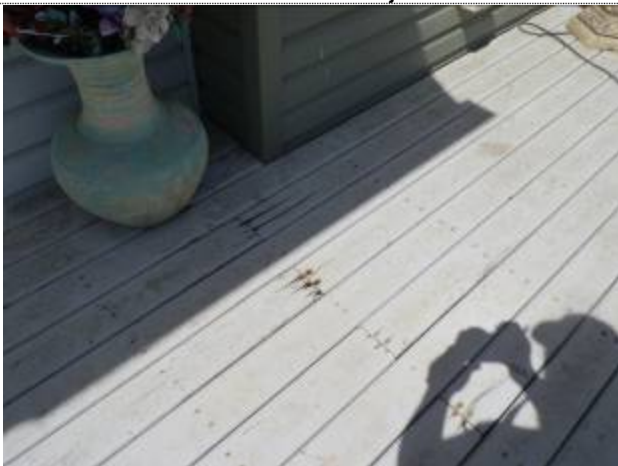
23
Deterioration at joints where screws penetrate

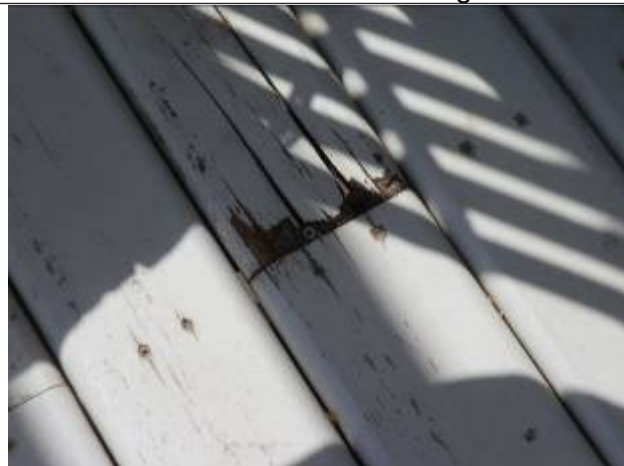
25
Deterioration at joints where screws penetrate

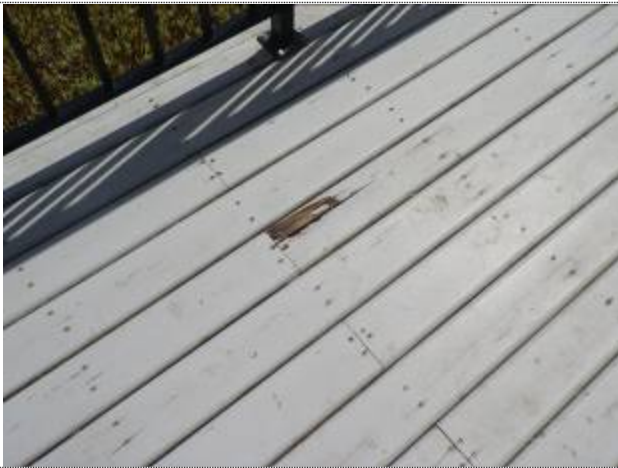
25

Deterioration at joints where screws penetrate

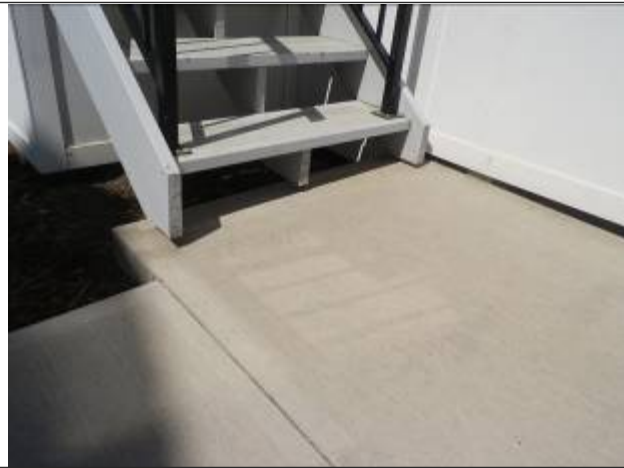
27

Steps do not rest on concrete

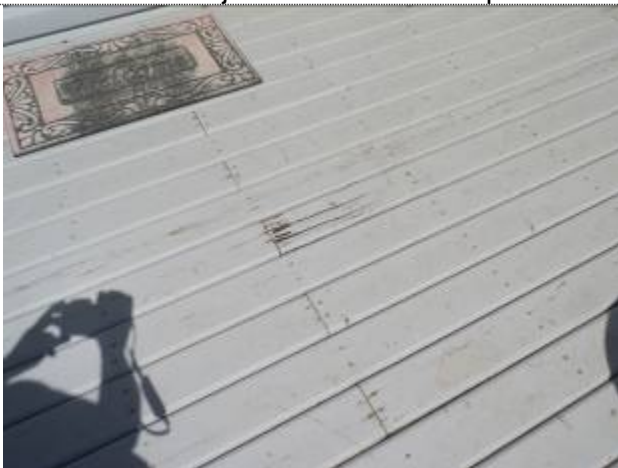
27

Deterioration at joints where screws penetrate

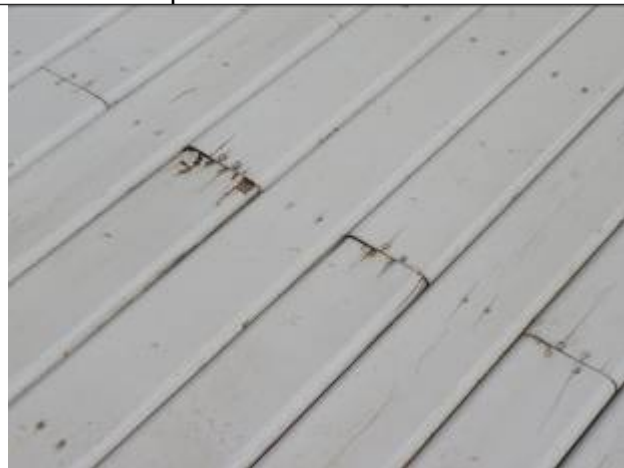
30

Deterioration at joints where screws penetrate

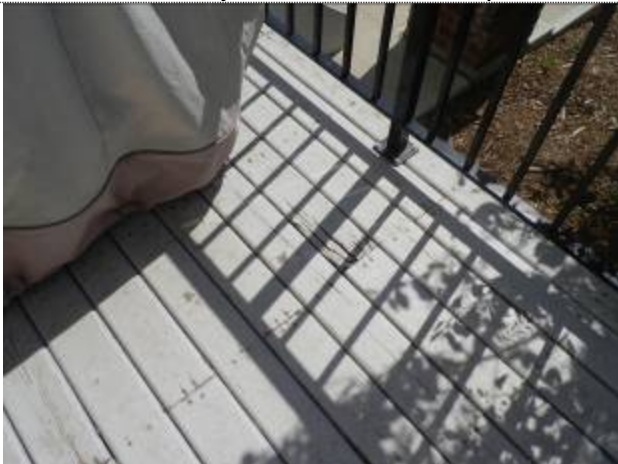
31

Deterioration at joints where screws penetrate

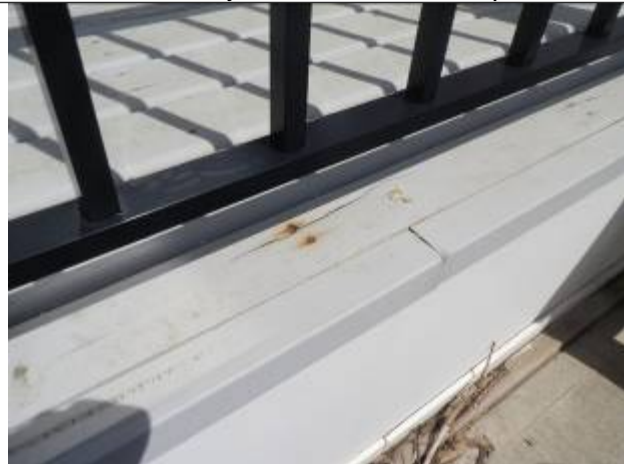
32

Rusted screw heads

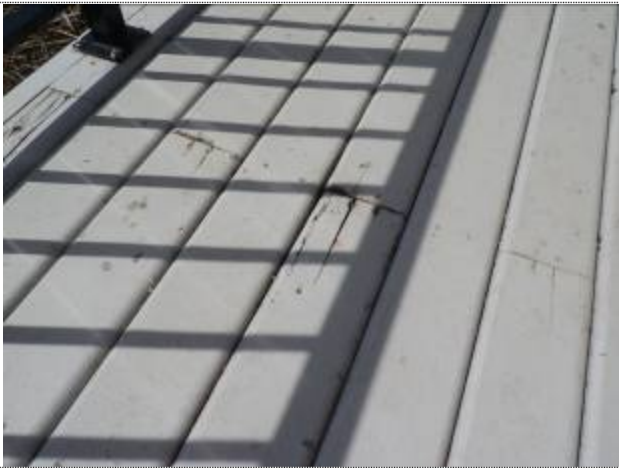
36

Deterioration at joints where screws penetrate

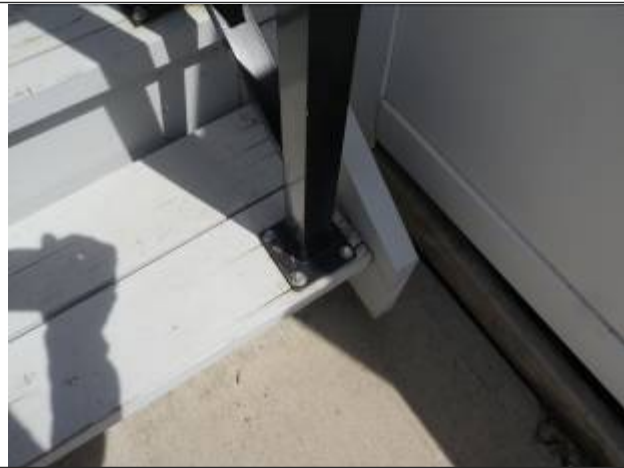
36

Damaged tread under railing

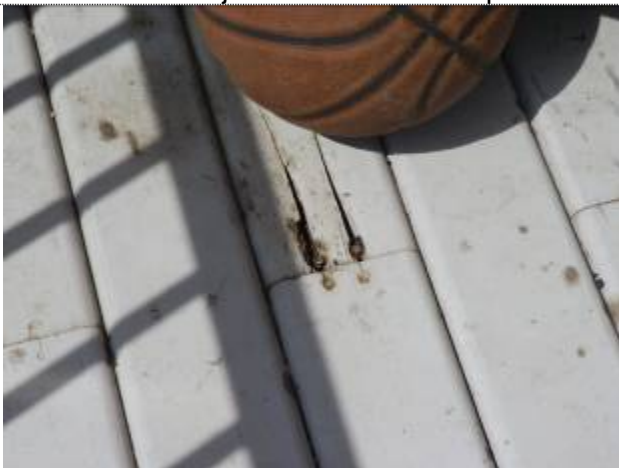
36

Deterioration at joints where screws penetrate

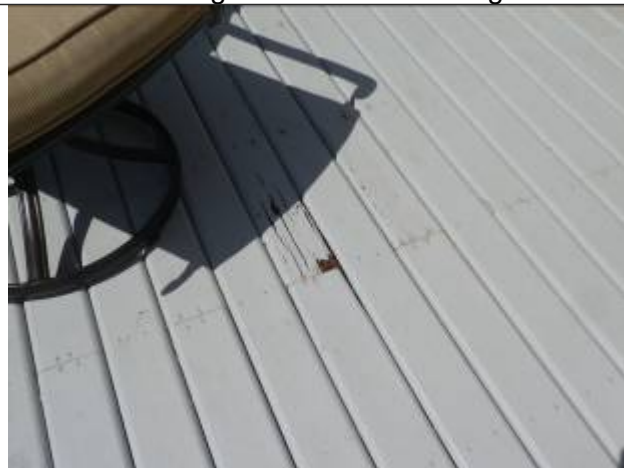
39

Deteriorated wood

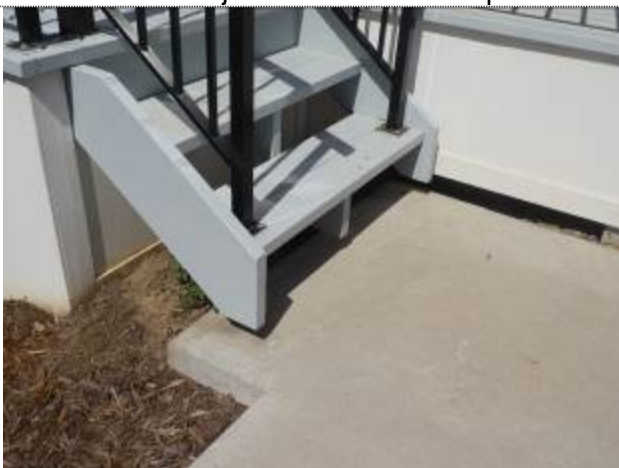
39

Steps do not sit on concrete

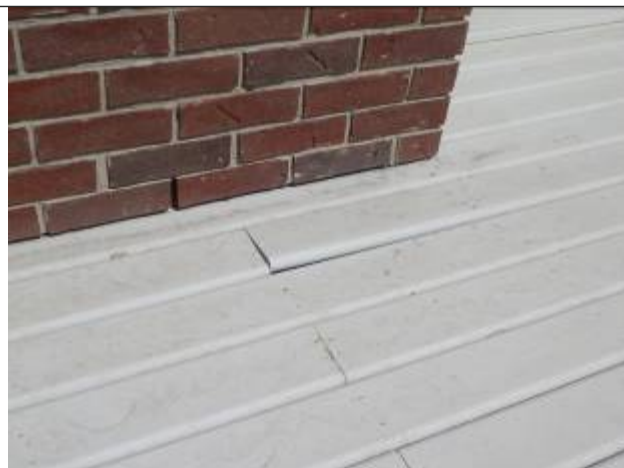
40

Board lifting – not secured

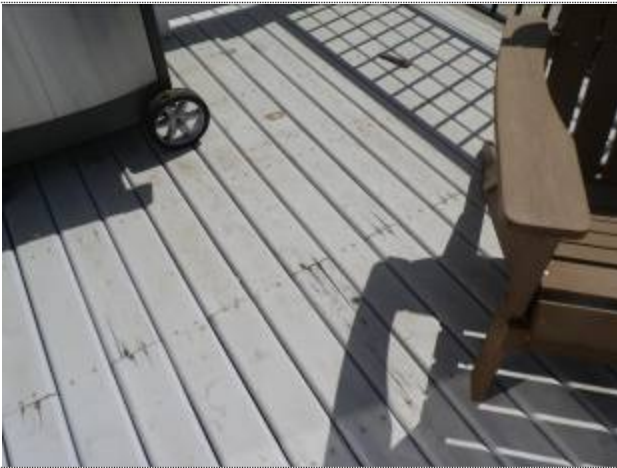
41

Deterioration at joints where screws penetrate

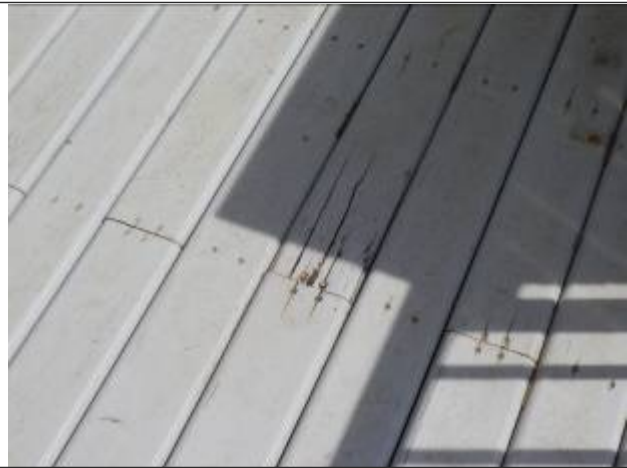
42

Deterioration at joints where screws penetrate

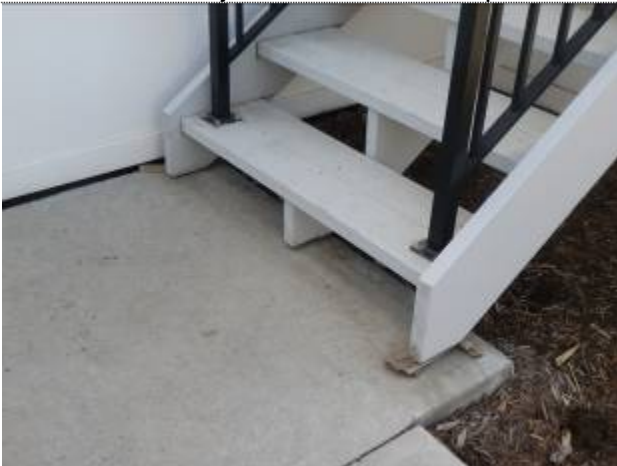
49

Steps don't rest on concrete

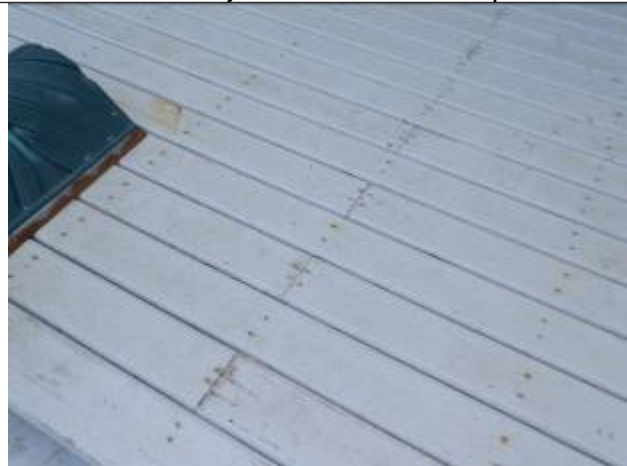
50

Minor deterioration at joints where screws penetrate

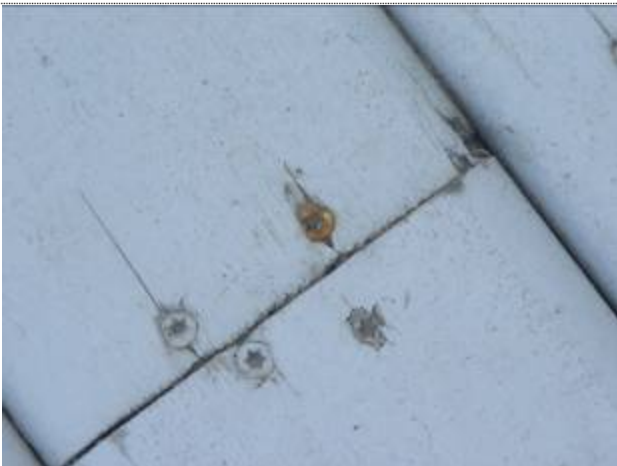
51

Only one screw rusting – suspect incorrect screws used

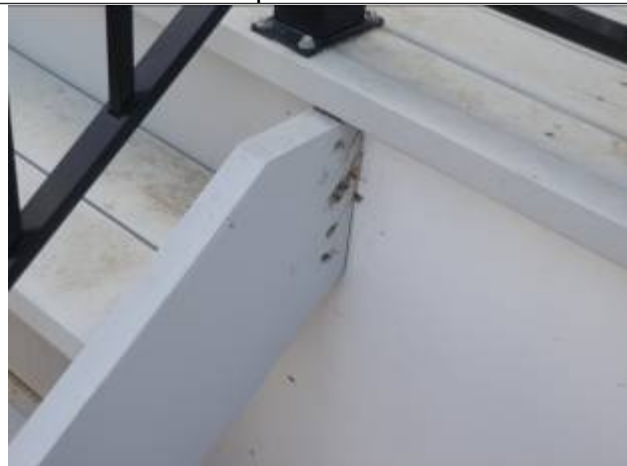
58

Poorly installed stringer
