RESERVE FUND STUDY
REPORT

CONDOMINIUM CORPORATION

CONDOMINIUM PLAN No. [REDACTED]

October 2023
Final

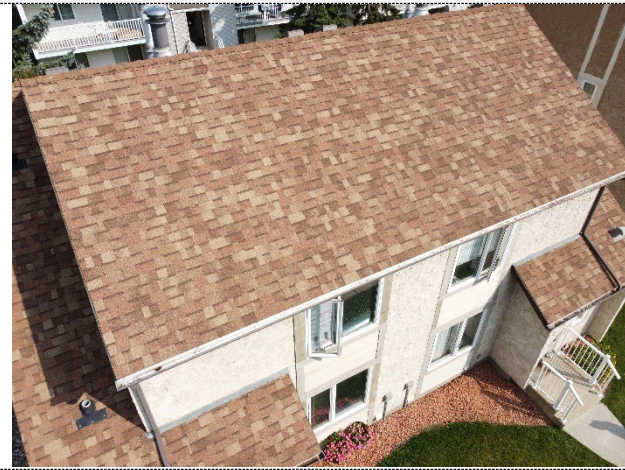
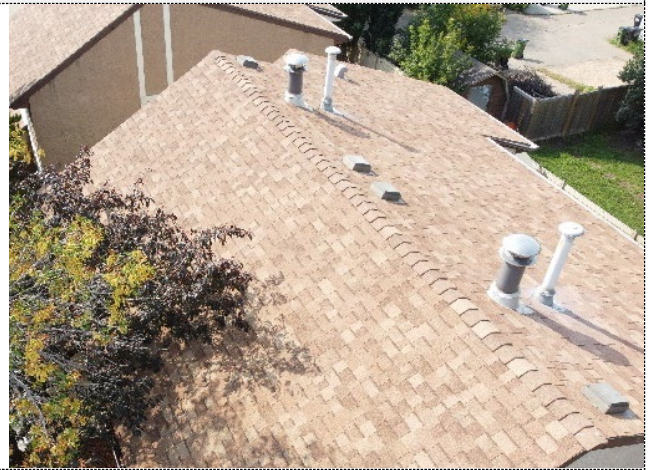
- Shingles are in good condition.
- No signs of deterioration or wear were noted.

Shingle roofing

– Inspect annually and repair as needed.

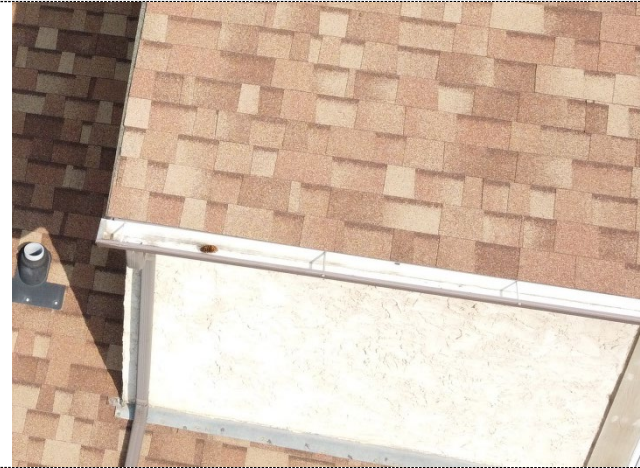
- Eavestroughs are securely fastened to fascia with ferrules (nails).
- Eavestroughs appear to be free of debris.
- Upper downspouts terminate into lower eavestroughs.
- Lower downspouts terminate into drains.
- Eavestroughs & downspouts are in fair condition.

Typical eavestrough

- Eavestroughs & downspouts should be cleaned annually.
- Cleaning should include minor repairs.

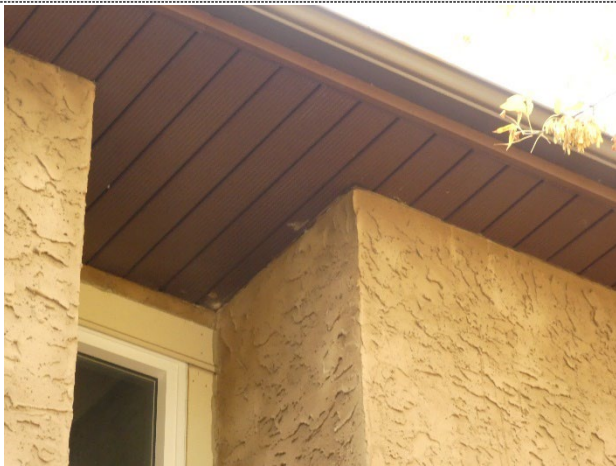
- Fascia is installed behind eavestroughs and at all roof terminations.
- Wood has been capped with metal behind eavestroughs. Wood fascia at roof terminations is original and evidencing deterioration.
- Soffit is vented painted metal and is installed at all roof overhangs. Vented soffit allows for air into the attic spaces.
- Metal fascia & soffit are in fair condition.

Soffit & fascia

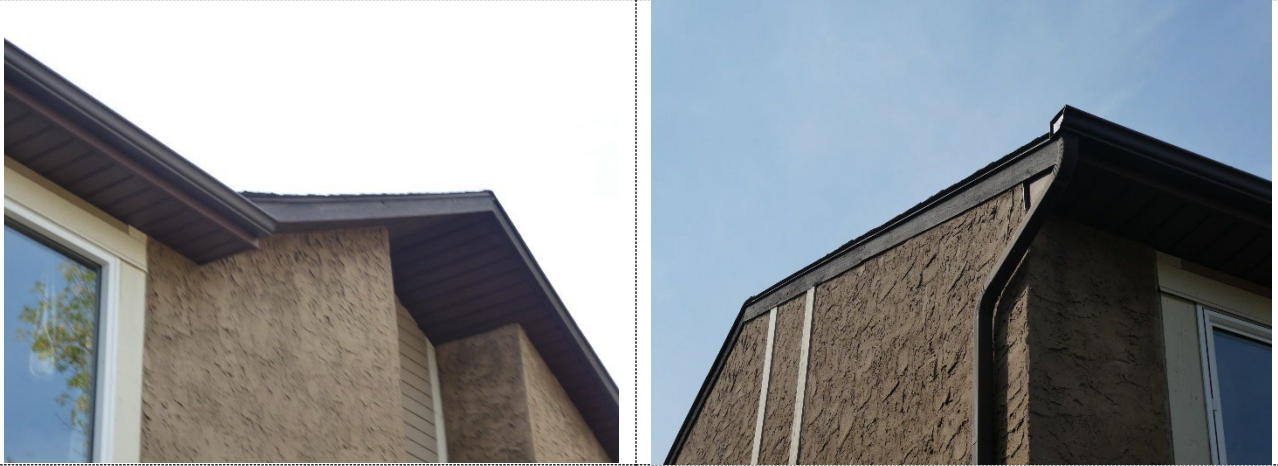
Component #	Recommendation	Page # in Report
3.0	Exposed wood fascia is installed at the termination of roofs. Wood fascia should be capped with metal within the next 2 years.	<u>15</u>

Wood fascia

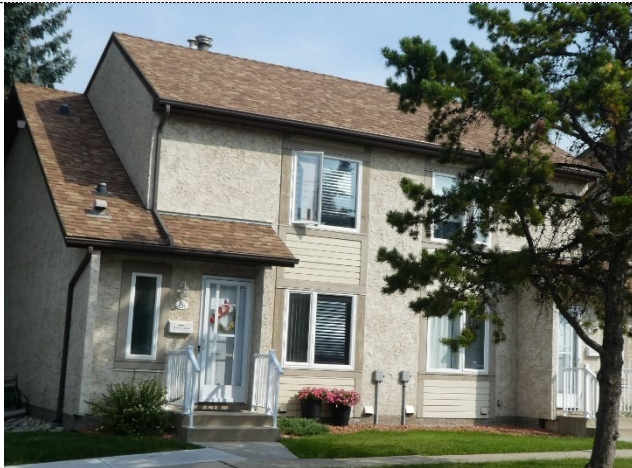
Stucco & wood siding

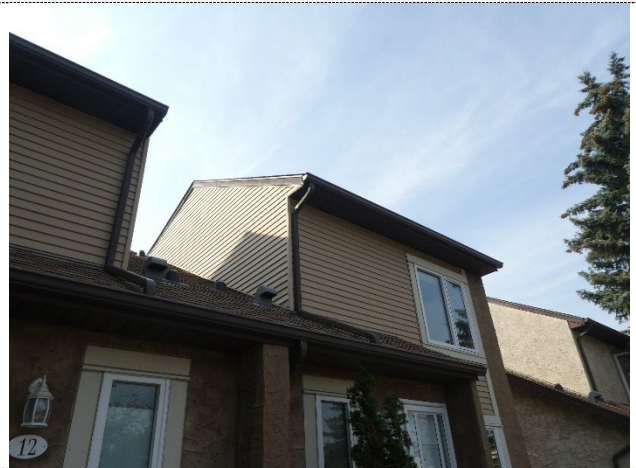
Metal siding

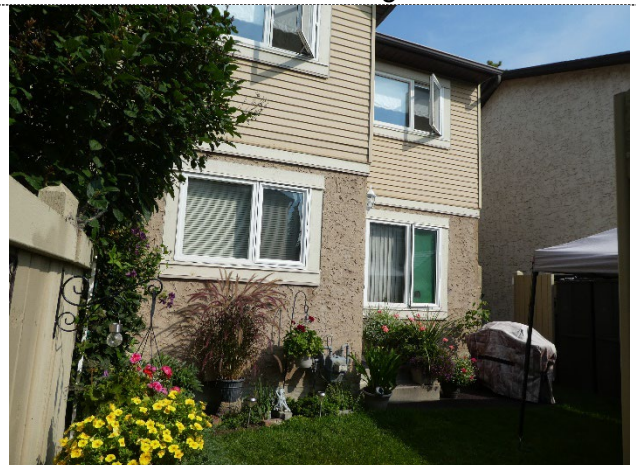
Stucco & metal siding

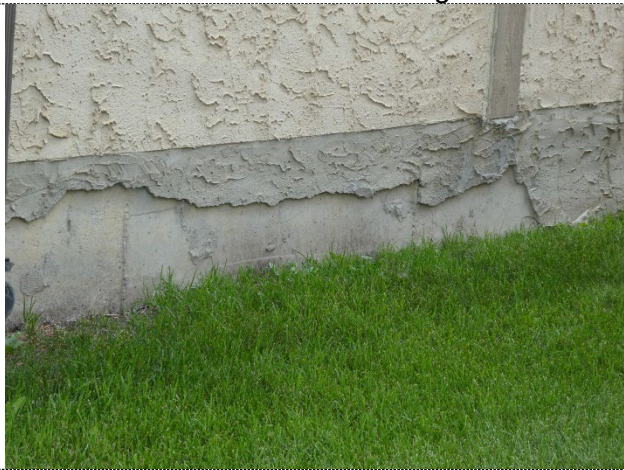
Flaking parging

- Funds are allocated within the next 4 years to paint & repair wood siding & trim, patch parging & repair metal siding.
- Penetrations through metal siding should be sealed.
- Stucco refurbishment would include patching and repairing damaged stucco and applying a thin fog coat application to the entire stucco surface. DO NOT paint stucco.

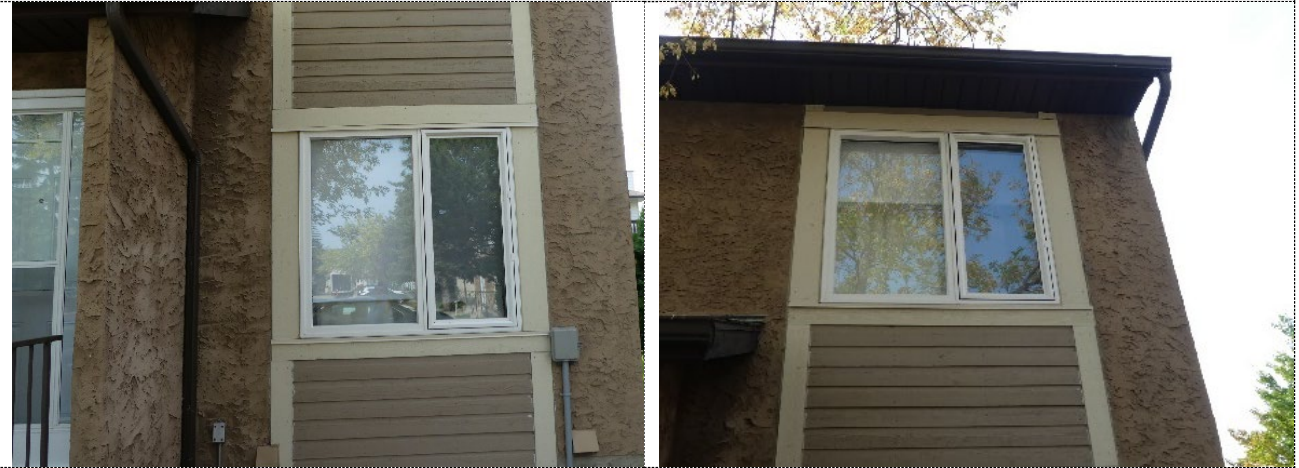
- Unit windows are not original and appear to be in good condition.

Front unit windows

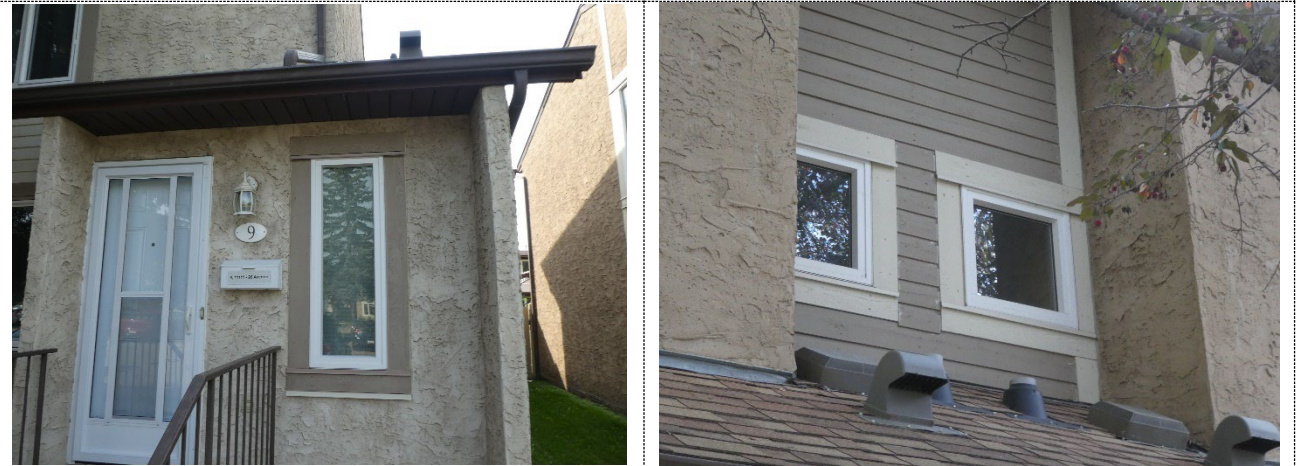
Front unit windows

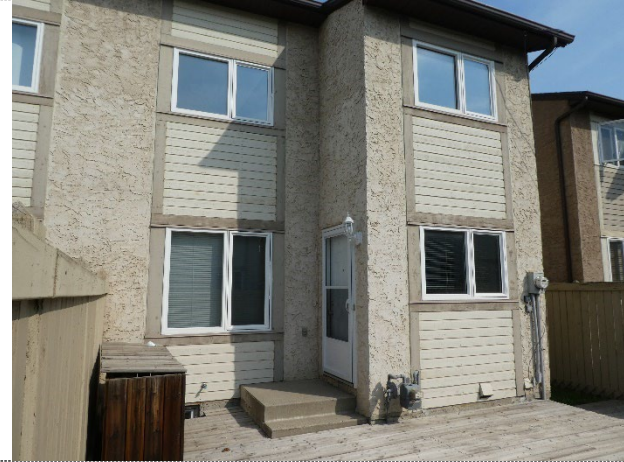
Back unit windows

- Regular maintenance of windows includes replacement of failed weather stripping/sealant and damaged hardware. Window sills and tracks should be cleaned on a regular basis to ensure proper drainage. Repair as necessary.

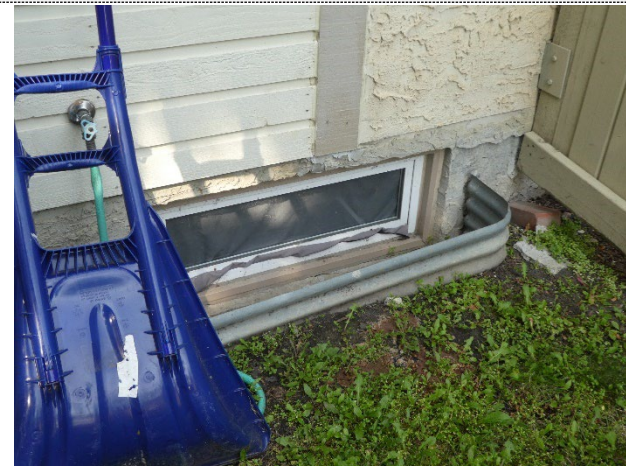
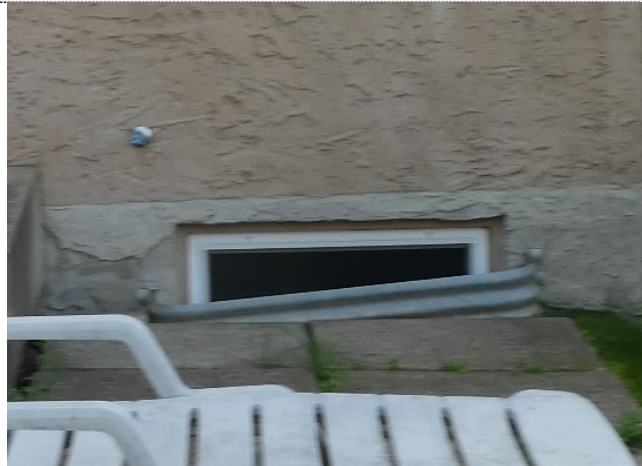
- Each unit has one basement window surrounded by a corrugated steel window well.
- Windows are PVC set into the concrete foundations.
- Windows are not original and are in good condition.
- Window wells are in fair condition. A few window wells are not securely fastened to foundation walls.

Basement window & well

- Ensure window wells are secured to foundations and free of debris & clutter to allow for proper drainage.

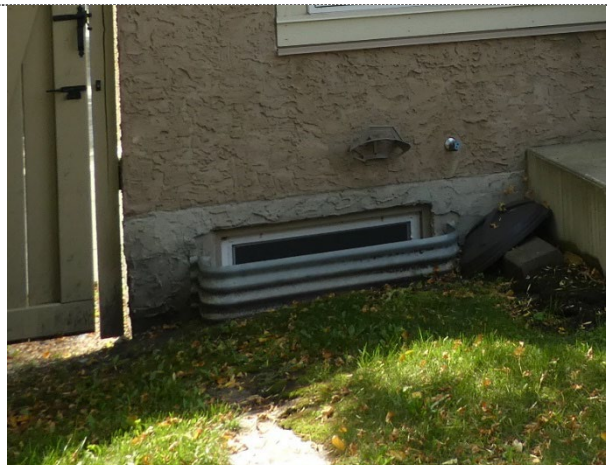
Basement window & well

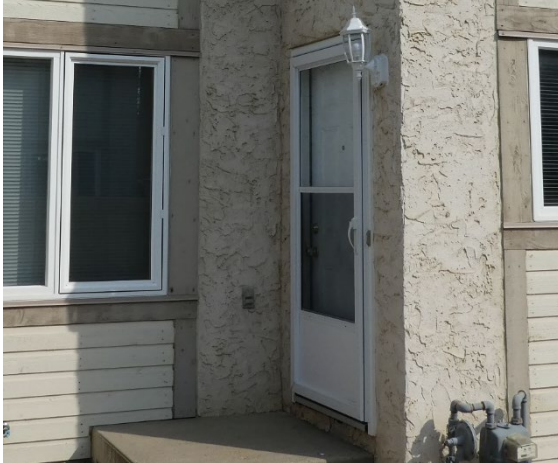
Typical back entrance door

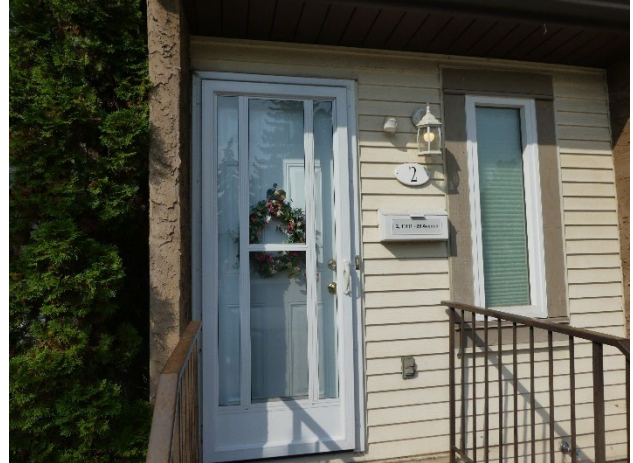
Typical front entrance door

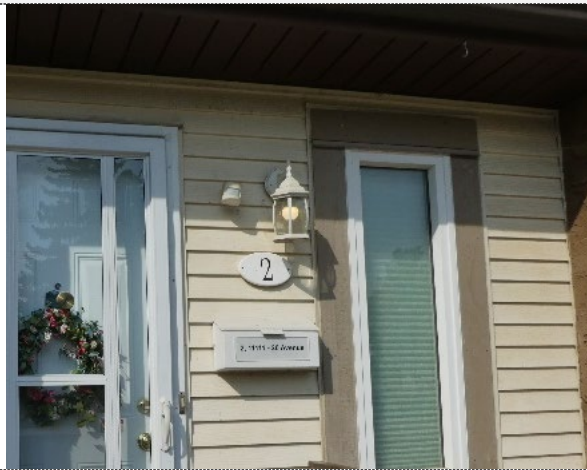
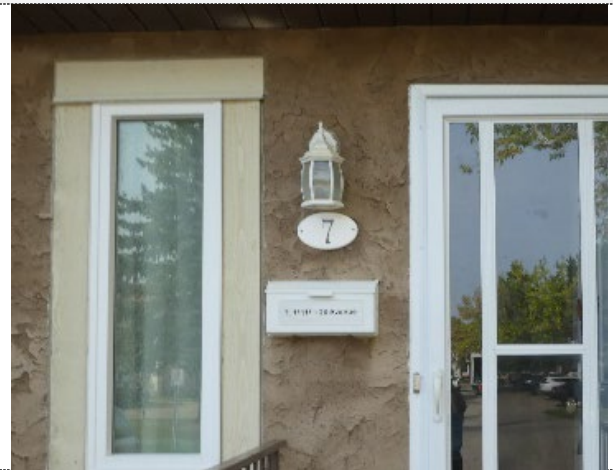
Front light, unit number & mailbox

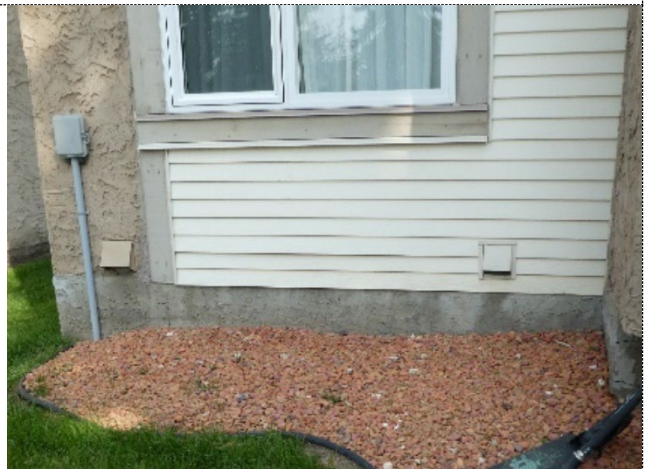
Vents

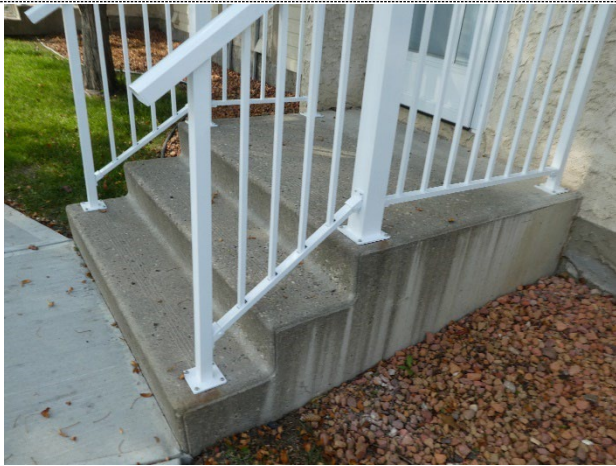
Front entrance step in fair condition – replaced railings

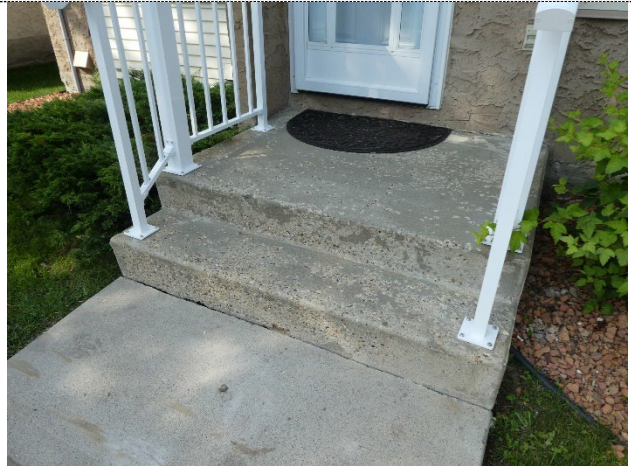
- The majority of the front and back precast entrance steps are original and vary in condition.
- A few steps have been replaced.
- Most front entrance steps are evidencing spalling.
- Back steps are uneven. Back steps are less spalled, as salt-based ice melt is most likely not used as much.
- Railings have been replaced this year on all steps.

Front entrance step evidencing deterioration

- Front steps should be replaced over the next 2 – 3 years. Railing replacement should have been completed after steps were replaced. Railings will require removal and installation on new steps.
- Back steps should be replaced over the next 6 – 7 years.

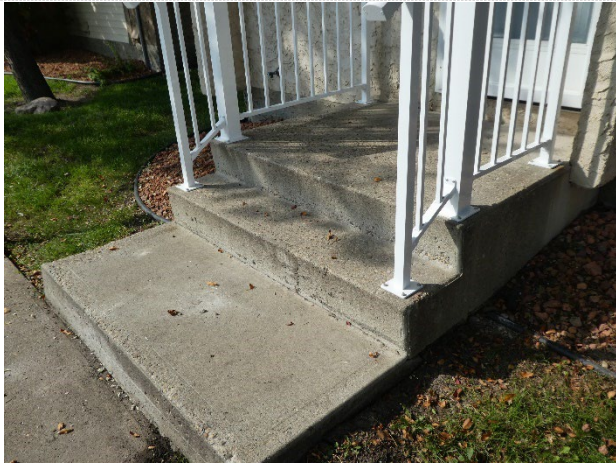
Front entrance step evidencing spalling

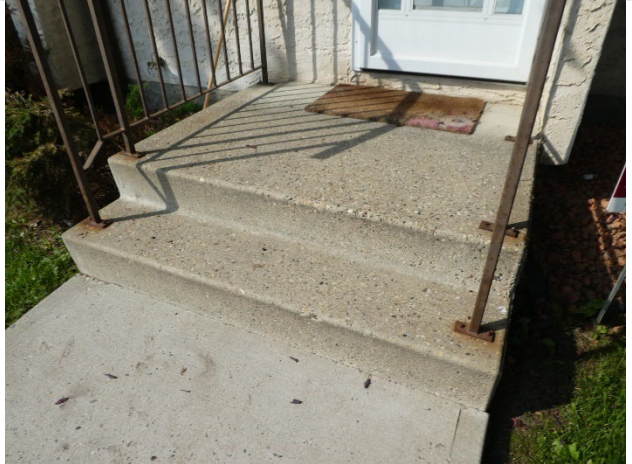
Front step spalled

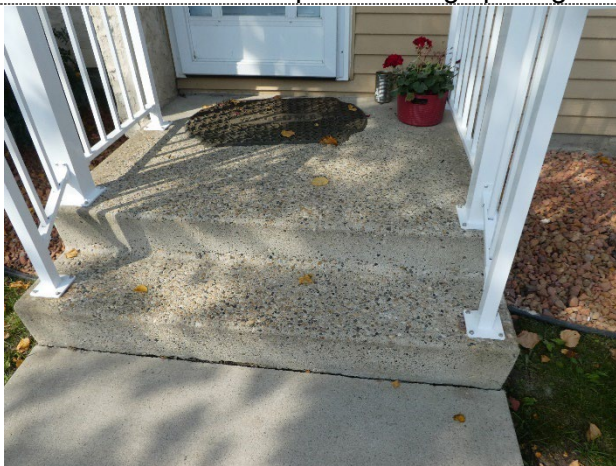
Significant spalling on steps

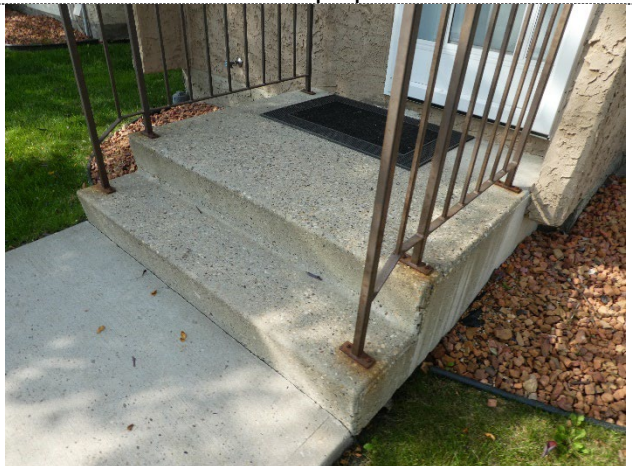
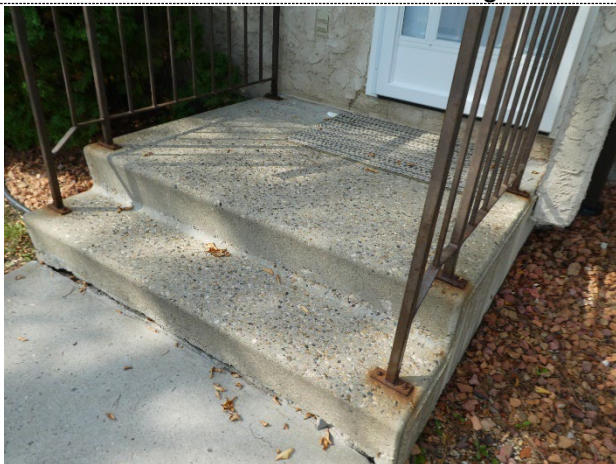
Significant spalling on steps

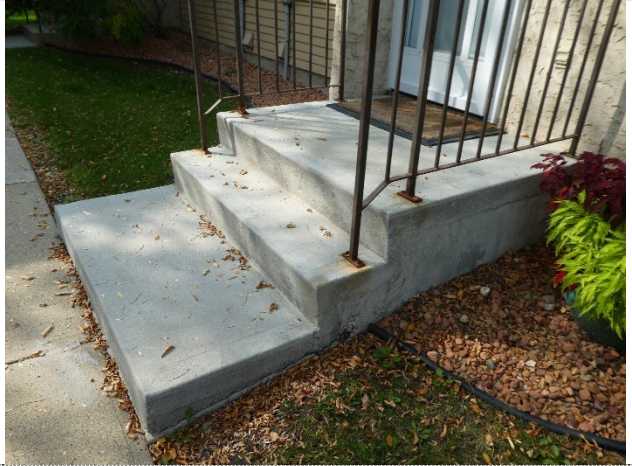
Replaced front steps

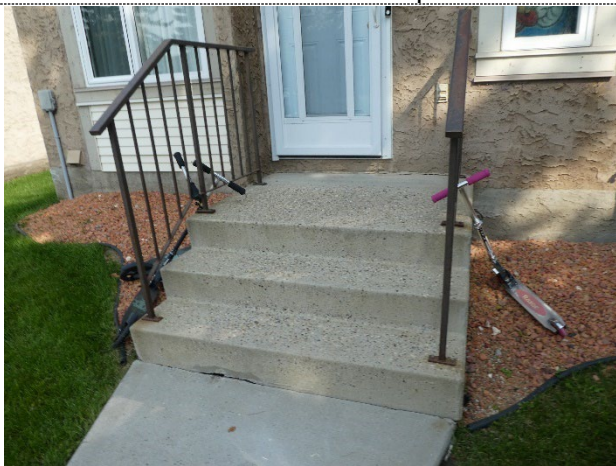
Spalled steps

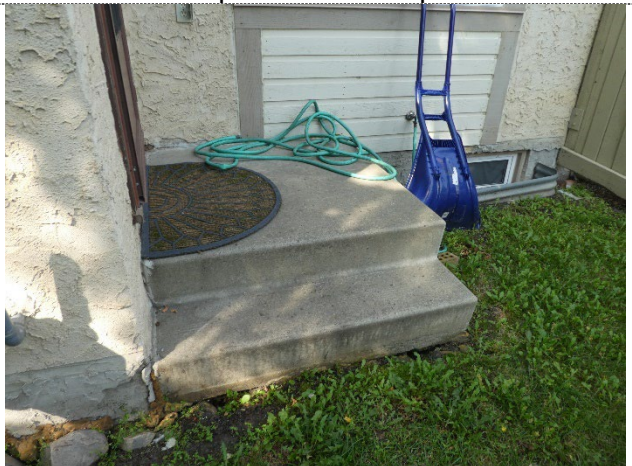
Typical back steps

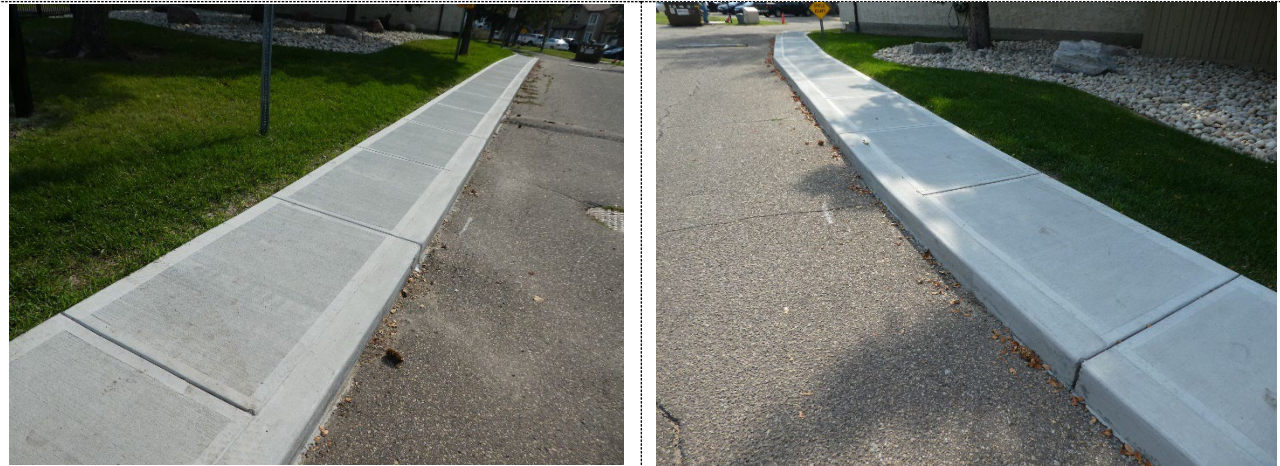
Property entrance walkways

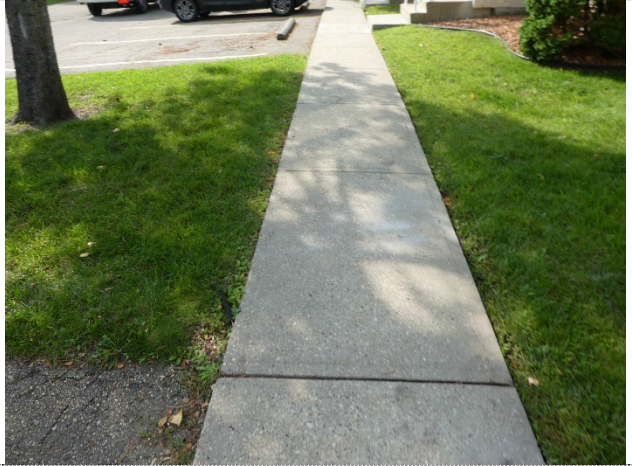
- Mudjacking of some walkway sections was being completed at time of inspection.
- Walkways installed around the perimeter of the asphalt are original and evidencing deterioration.
- Unit walkways were replaced approximately 8 years ago and are in good condition.
- Walkways were installed along both sides of the entrance to the property. These walkways are in good condition.
- Garbage bin pads were recently installed and in good condition.

Perimeter walkways

- Perimeter walkways should be replaced over the next 2 years.
- Mudjacking alleviates settlement – not spalling and deterioration.
- It is recommended that salt-based ice melt products not be used.

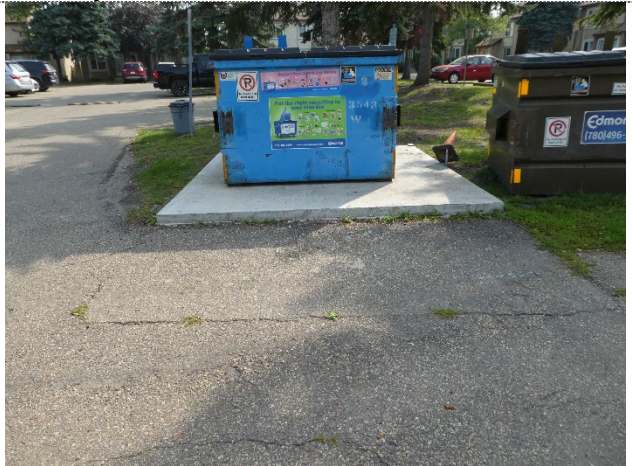
Garbage bin pad

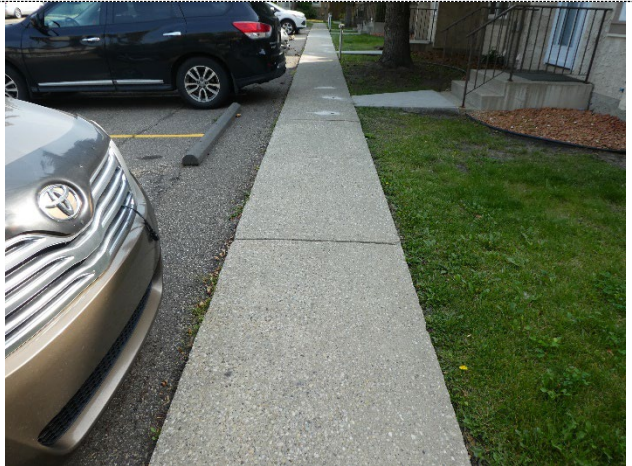
Perimeter walkways

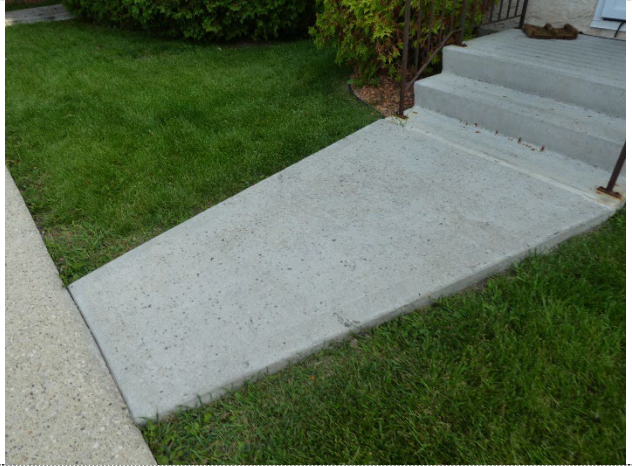
Unit walkway

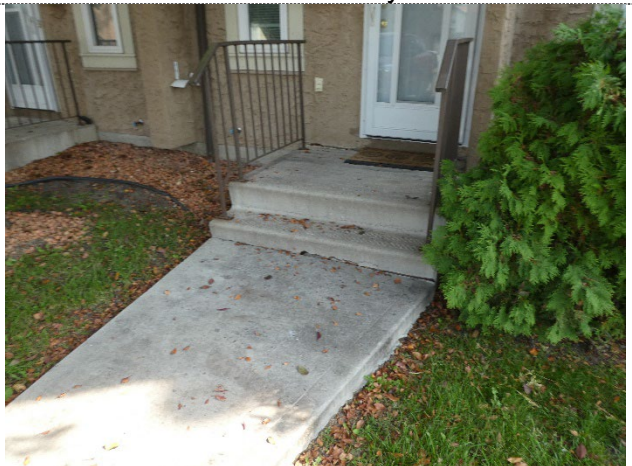
Perimeter walkways

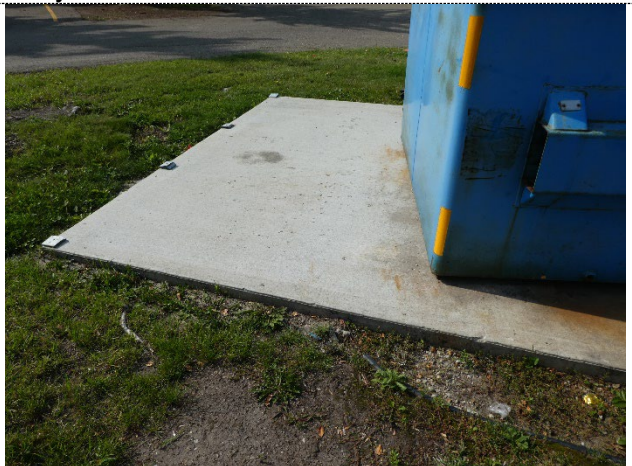
Garbage bin pad

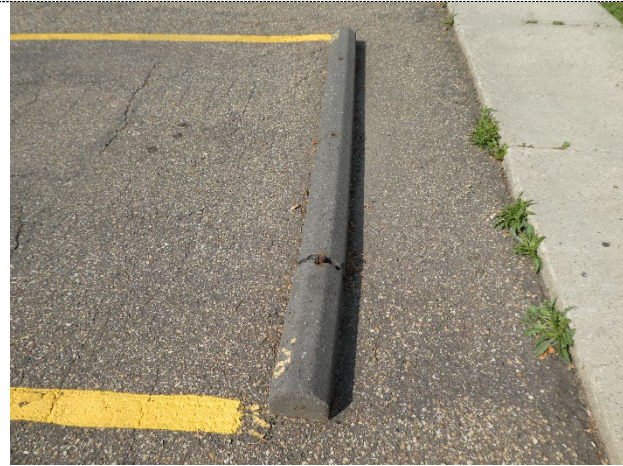
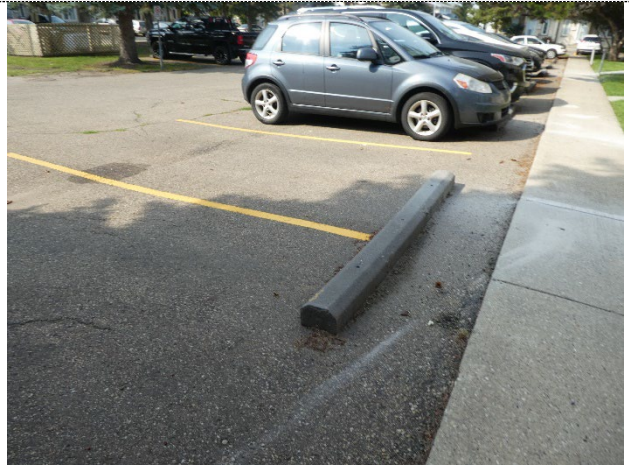
- Precast curbs are new and in good condition.

Typical precast curbs

- PM advised that precast curbs were replaced after inspection.
- Precast curbs will require removal when asphalt is resurfaced in 3 years.

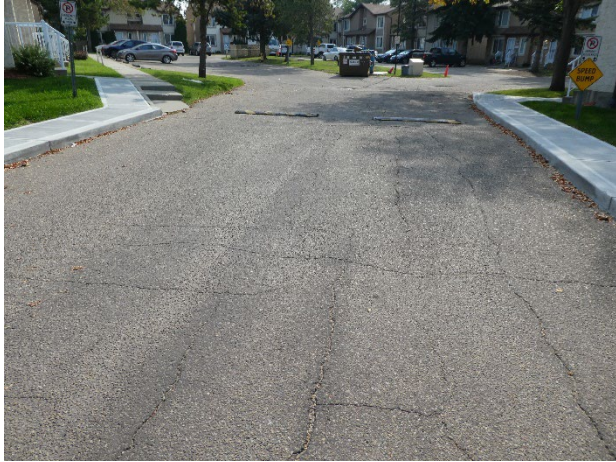
- Asphalt parking & roadways are evidencing wear and deterioration.

Asphalt roadway at entrance

Parking & Roadways – continued		
Recommendations for Replacement and/or Maintenance		
<ul style="list-style-type: none"> – Damaged areas of asphalt (pot holes) should be filled this spring/summer. – Asphalt should be resurfaced within the next 3 years. 		
Projection		
<i>Year Replacement Required:</i>		<i>Cost of Replacement with Inflation:</i>
Parking & Roadways	2026	\$261,407
Major Repair	2024	\$10,500

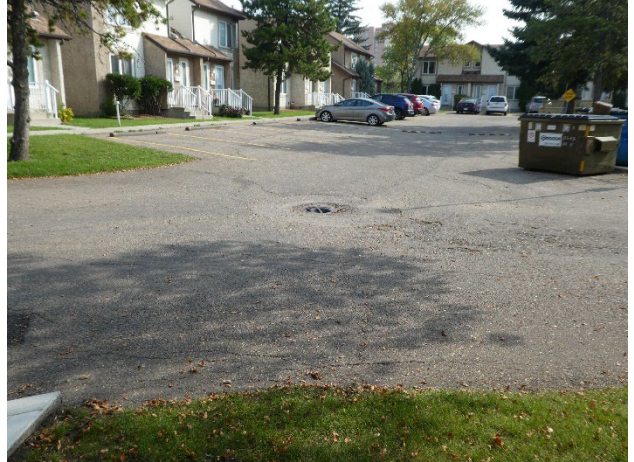
Asphalt roadway

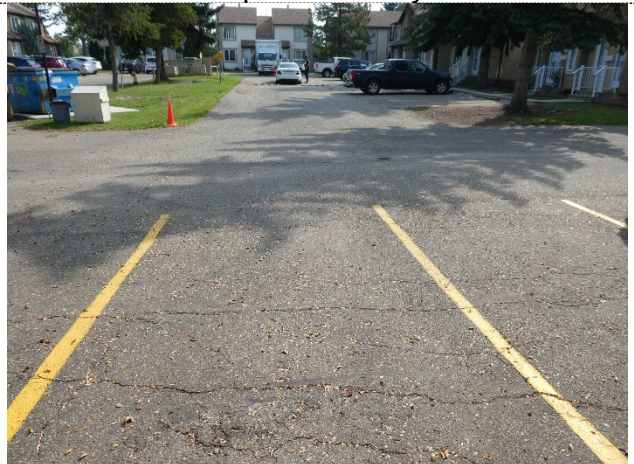
Asphalt parking & roadways

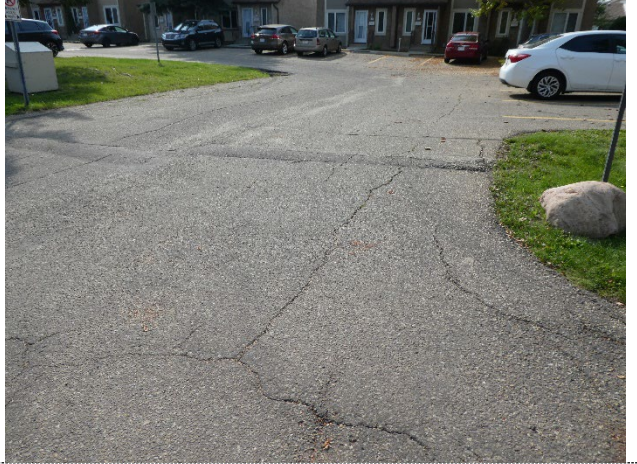
Asphalt roadway

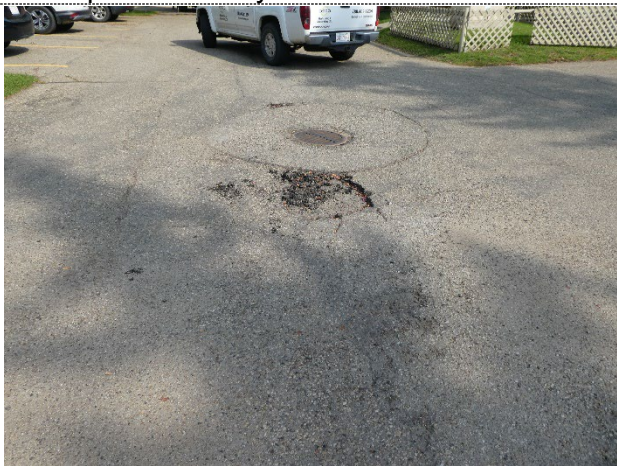
Deteriorated asphalt

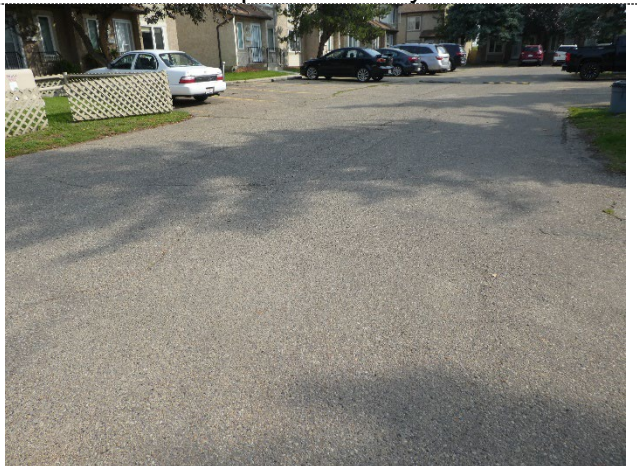
Roadway

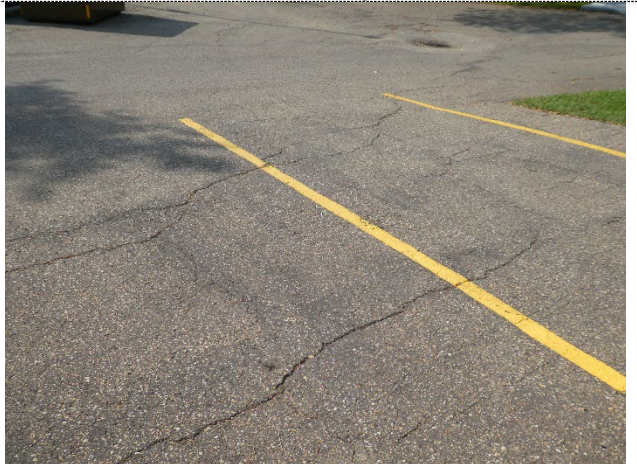
Parking stalls

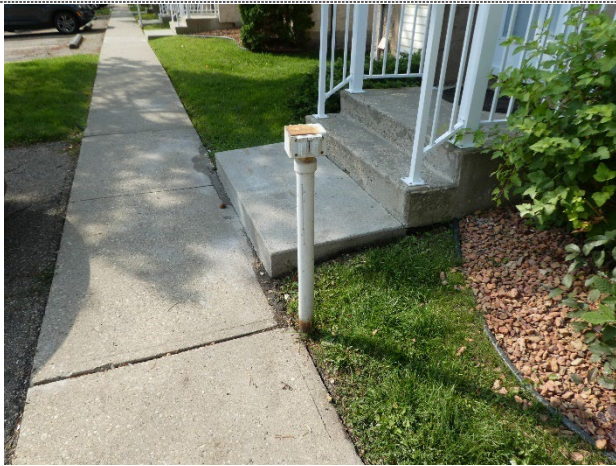
- Vehicle outlets are installed on metal poles in the landscaping adjacent to the walkways around the parking areas.
- Vehicle outlets vary in condition. A few outlets appear to have been replaced. Most outlets are at the end of their effective life.
- Posts and housing are rusted.
- Site lighting is installed throughout the property. Site lighting is not original and in good condition.
- Underground electrical lines run to each outlet & site light. These lines can not be inspected for this report. Lines are original.

Typical vehicle outlet

13.0	Vehicle outlets vary in condition. Most outlets have reached the end of their effective life and should be replaced within the next 2 years.	<u>37</u>

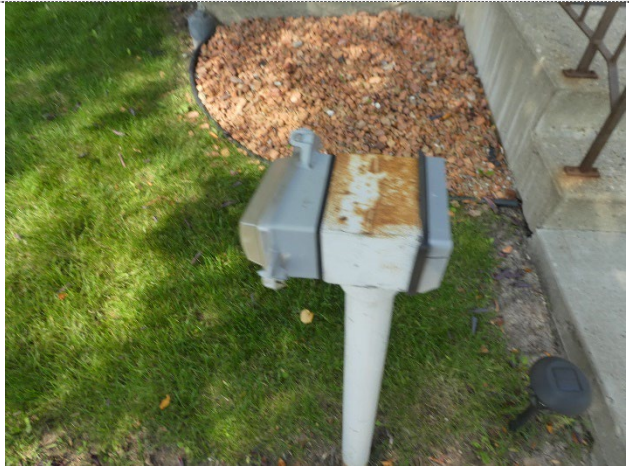
Rusted housing

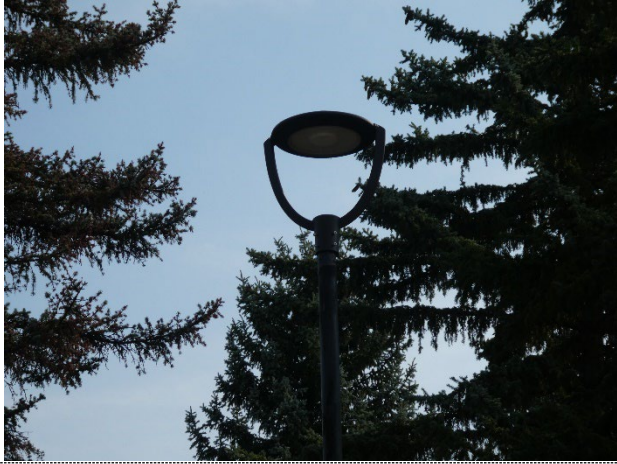
Site lighting

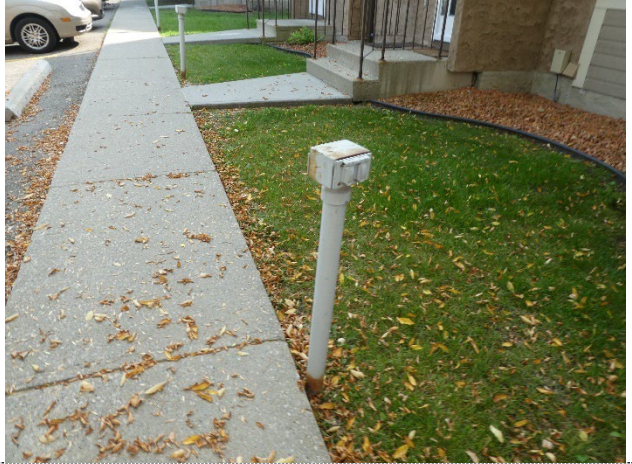
Vehicle outlet

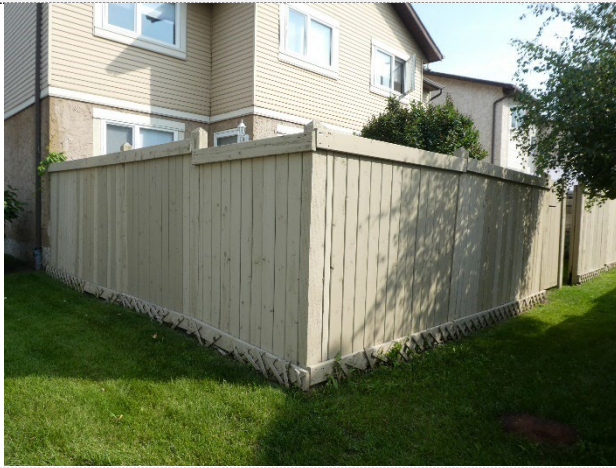
- Wood fencing is installed around the perimeter of the property.
- Wood fencing is also installed around the unit back yards.
- Fencing is in fair condition.

Unit fencing

- Paint & repair wood fencing again within the next 4 years.

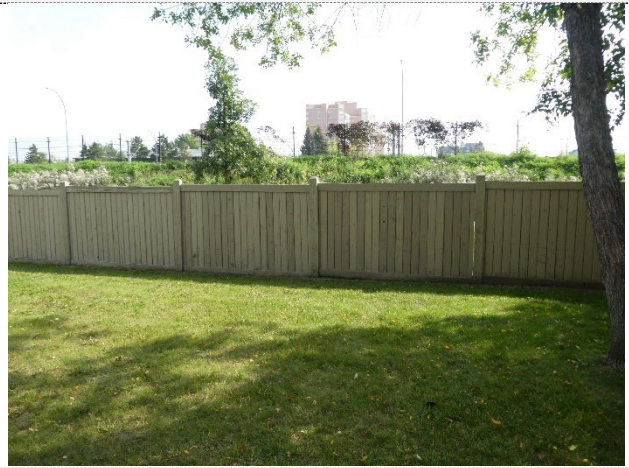
Perimeter fencing

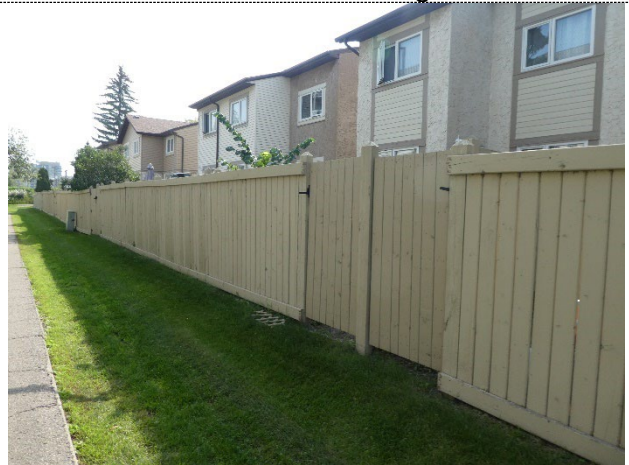
Unit fencing

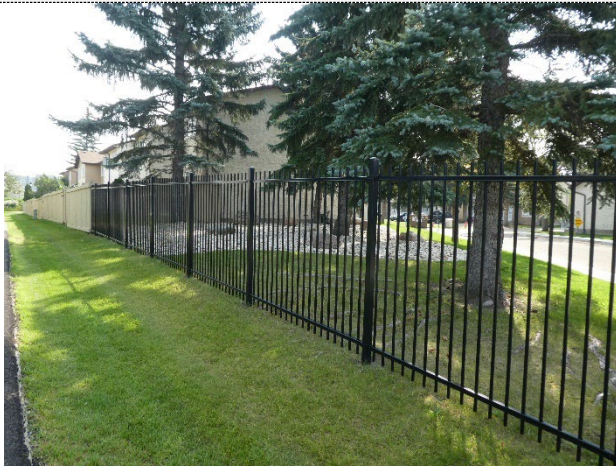
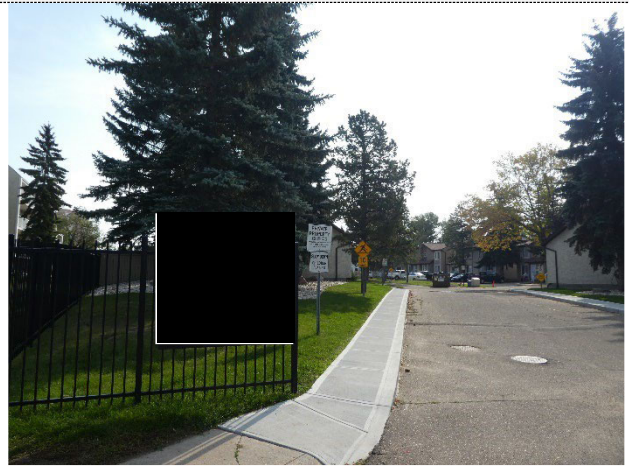
New property signage and fencing at entrance

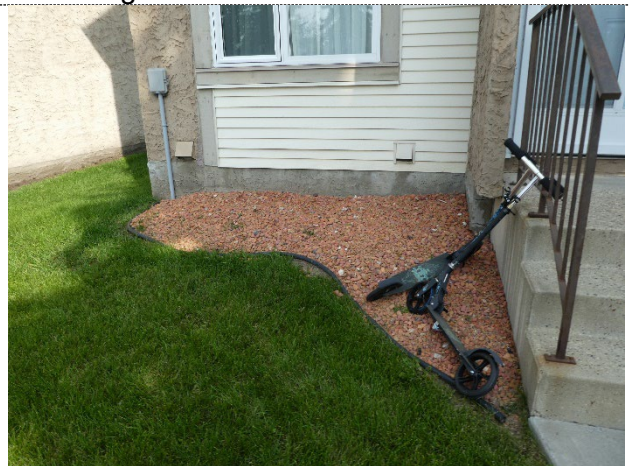
Landscaping at front of unit

- Landscaping will settle over time and may leave the ground sloped towards the building foundations. Settling also leaves the potential for uneven walking surfaces and tripping hazards. Re-grading as necessary will help limit the chances of water entry. Funds are allocated within the next year to complete grading.
- Funds are allocated every 5 years to complete foundation repairs as needed.

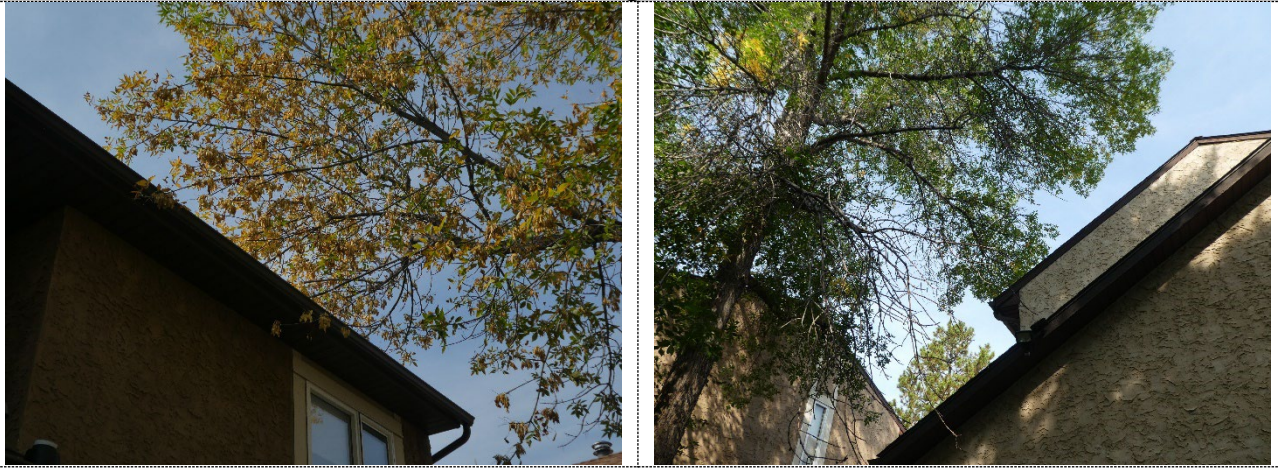
- Landscaping consists of mature trees, shrubs, rock & grass.
- Large trees are growing close to the buildings. Branches are scraping against building components.
- The slope of the landscaping is suspect in some locations.
- Property signage & wrought iron fencing were installed at the front of the property. Signage and fence are in good condition.
- Corporation has completed foundation repairs in the past.

Trees scraping against building components

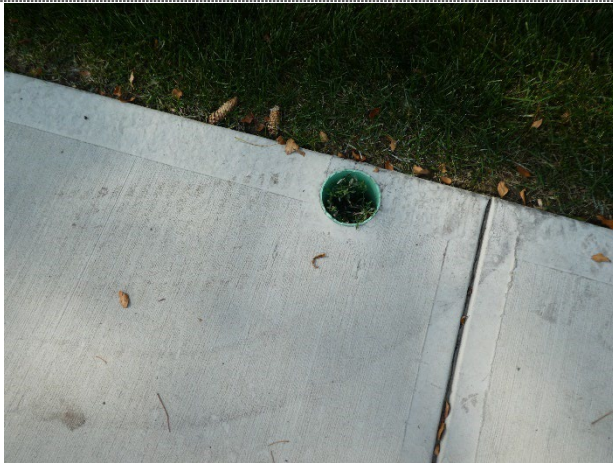
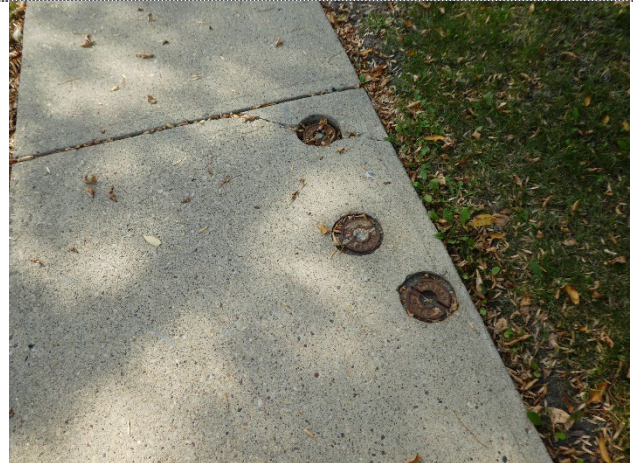
Shut off valves in walkway

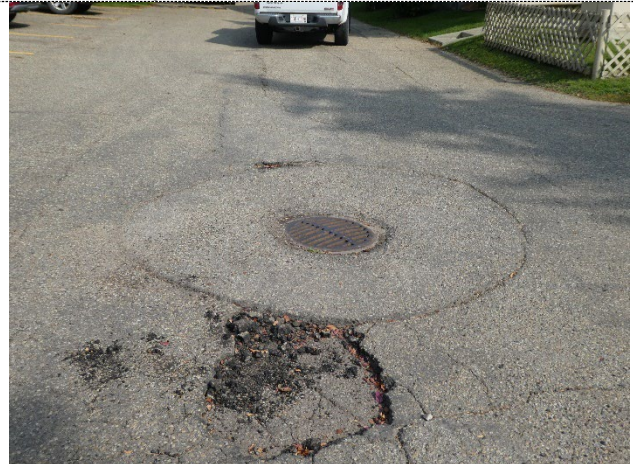
Drain in roadway
