RESERVE FUND STUDY
REPORT

CONDOMINIUM CORPORATION

CONDOMINIUM PLAN No. [REDACTED]

October 2023
Final

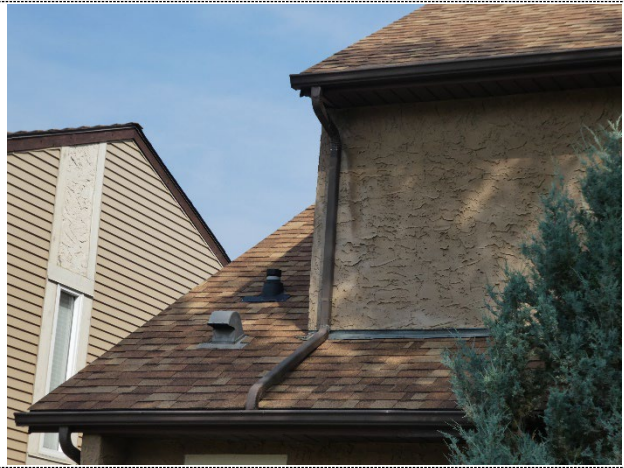
Upper downspout terminating into lower eavestrough

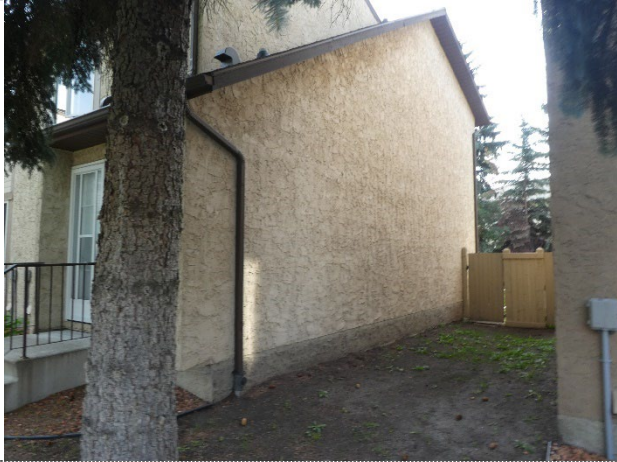
Stucco at end of building

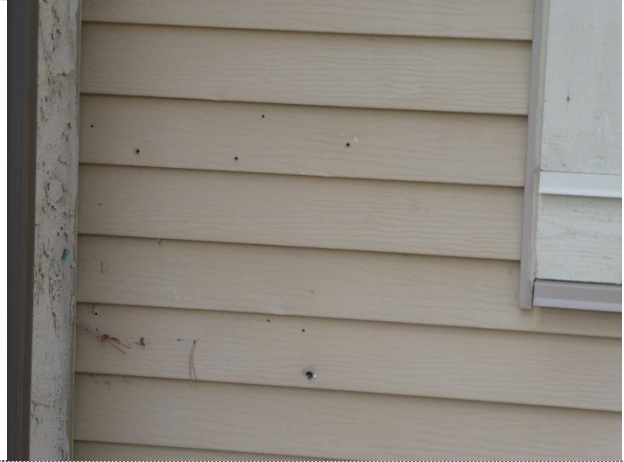
Holes in metal siding

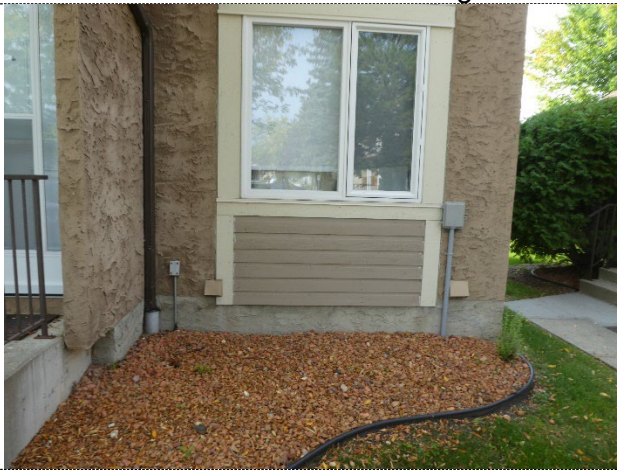
4.0	Wood siding & trim are in good condition. Wood should be painted & repaired within the next 4 years and every 6 years.	<u>17</u>
8.0	Back unit lighting was replaced this year.	<u>23</u>

Wood siding & trim

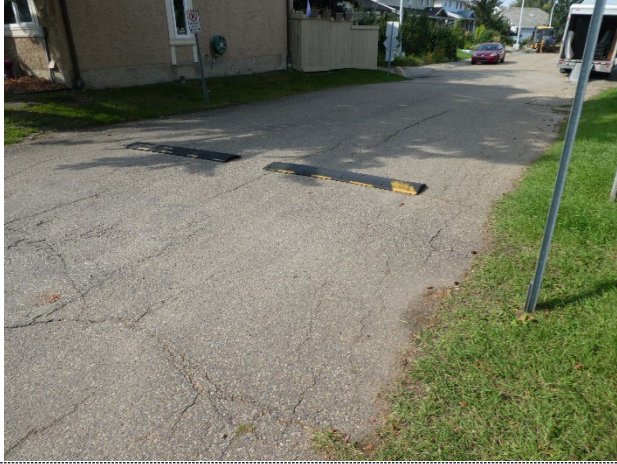
11.0	Precast curbs were scheduled to be replaced this year. PM advised that this was to be completed after original inspection.	<u>33</u>
12.0	The asphalt parking & roadways is evidencing wear. Resurfacing should be completed within the next 3 years. Funds are allocated next year to repair pot holes.	<u>34</u>

Asphalt roadway between north & south
