RESERVE FUND STUDY
REPORT

CONDOMINIUM CORPORATION

CONDOMINIUM PLAN No. [REDACTED]

October 2023
Final

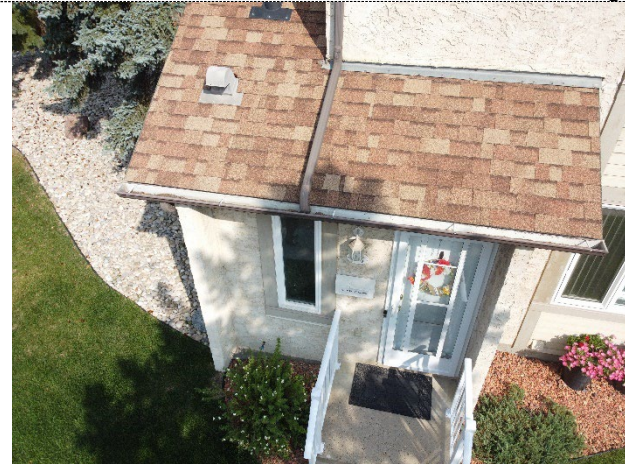
Shingle roofing

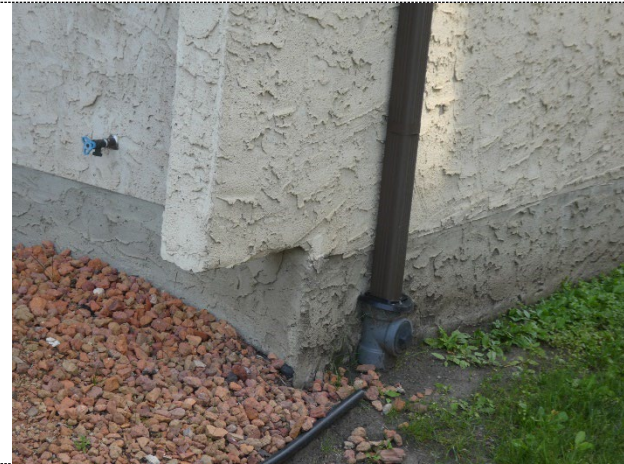
Downspout terminating into drain

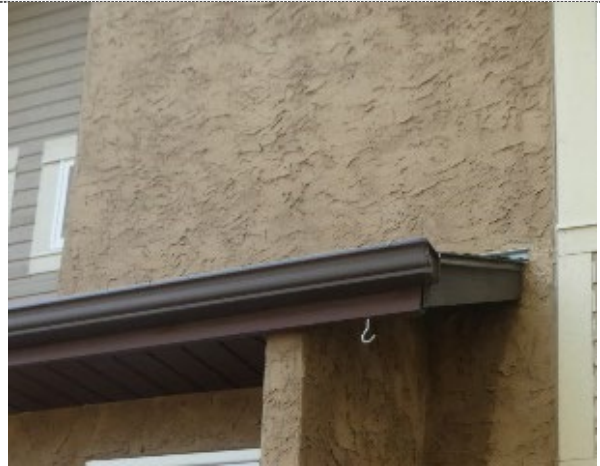
Component #	Recommendation	Page # in Report
3.0	Exposed wood fascia is installed at the termination of roofs. Wood fascia should be capped with metal within the next 2 years.	<u>15</u>

Wood fascia

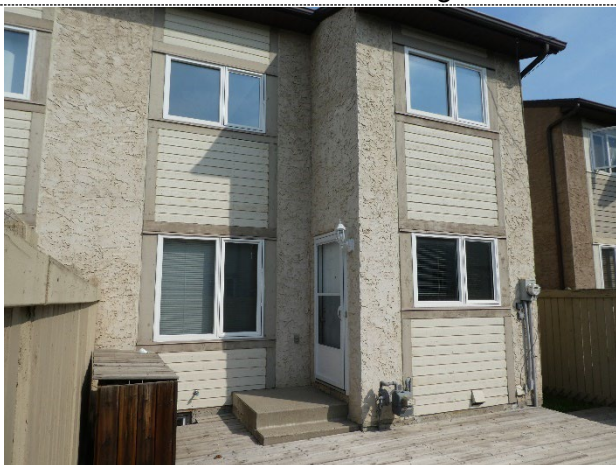
Stucco & wood siding

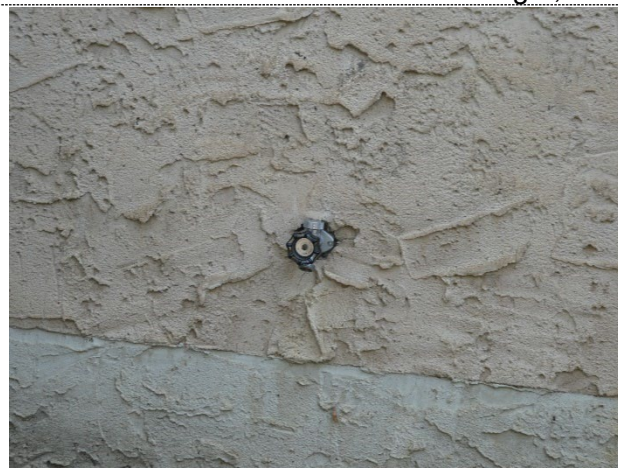
Hose bib

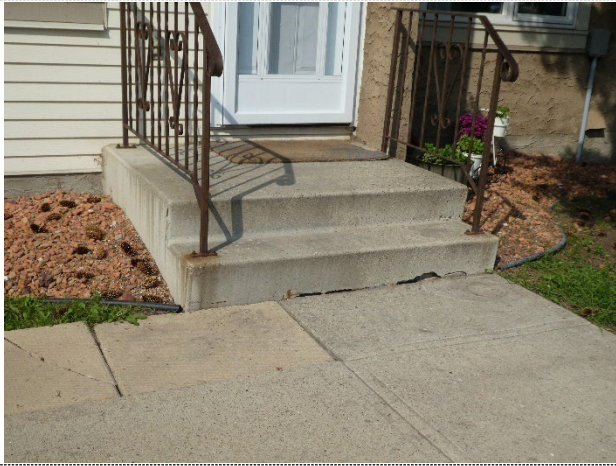
9.0	Front precast steps are exhibiting spalling and have reached the end of their effective life. Front steps should be replaced within the next 2 – 3 years. Railings were replaced this year. Railings will require removal and re-installation after new steps are installed.	<u>25</u>

Front entrance steps

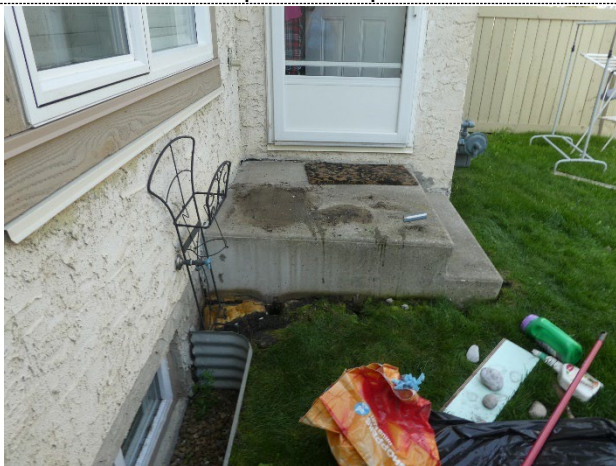
Back steps

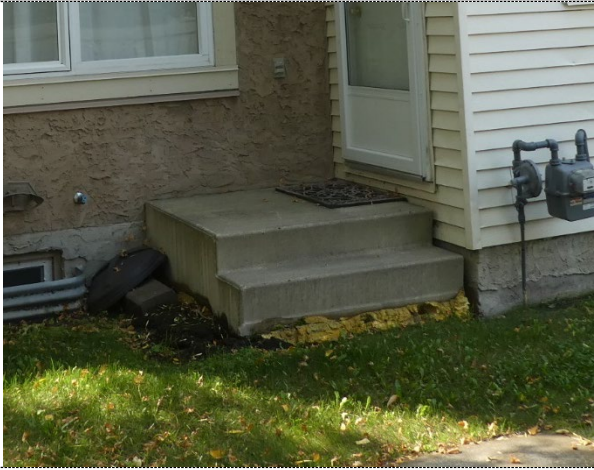
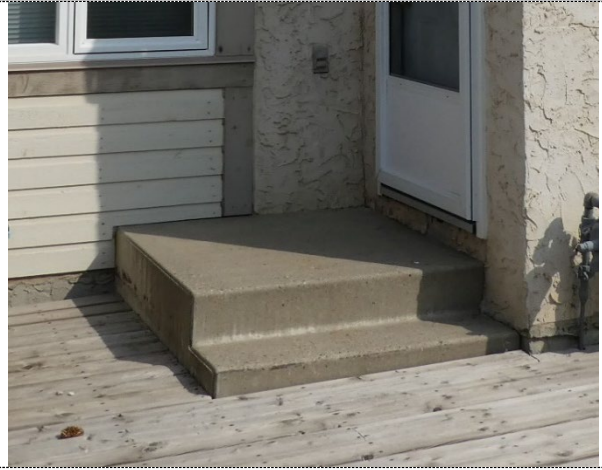
Back steps

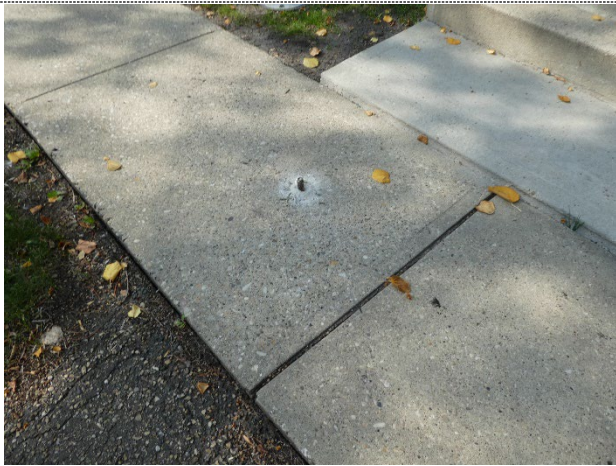
10.0	Walkways installed around the perimeter of the parking & roadways are original. These walkways are exhibiting spalling & deterioration. Mudjacking was recently completed. This does not eliminate spalled and cracked walkway tripping hazards, only uneven concrete. Perimeter walkways should be replaced over the next 2 years.	<u>29</u>

Perimeter walkway

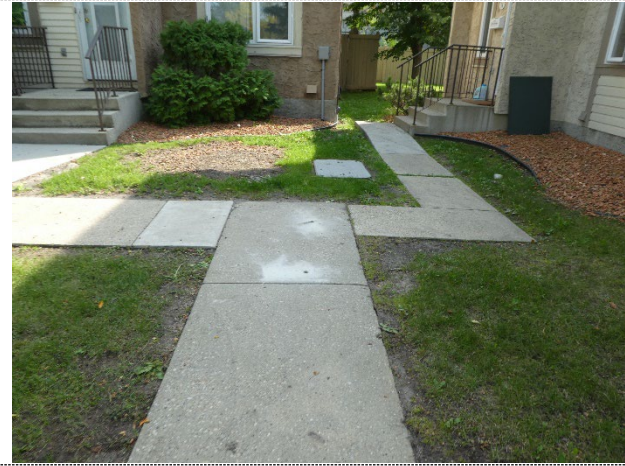
Perimeter walkways

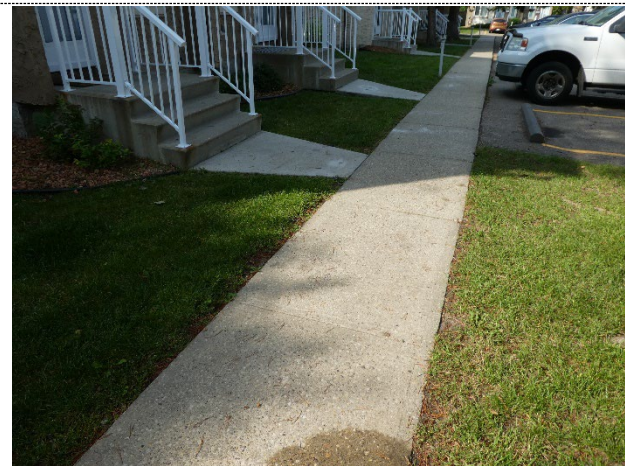
Perimeter walkways

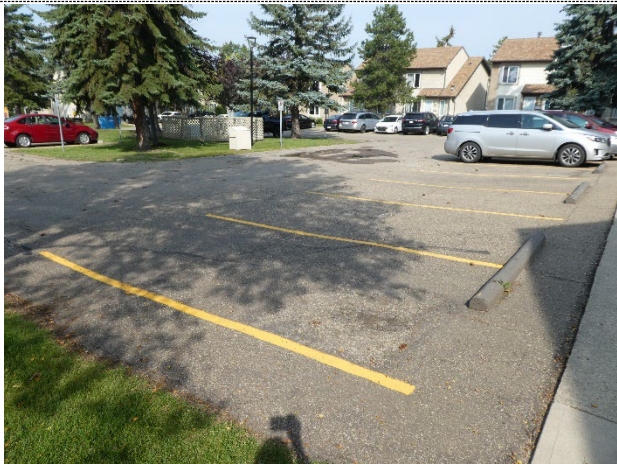
Parking stalls

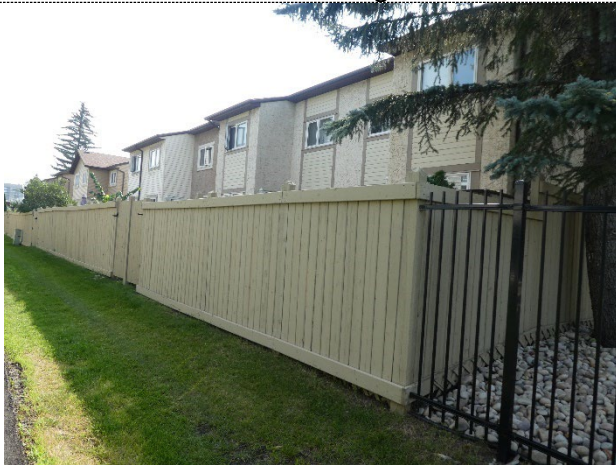
14.0	Wood fencing should be painted again within the next 4 years. Paint costs include minor repairs.	<u>39</u>
15.0	Funds are allocated next year to address grade and slope issues throughout the property. Funds are also allocated every 5 years to repair foundations.	<u>40</u>

Unit fencing

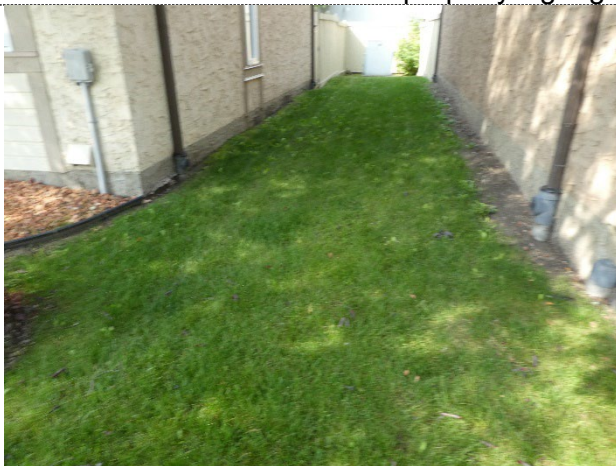
Landscaping between buildings

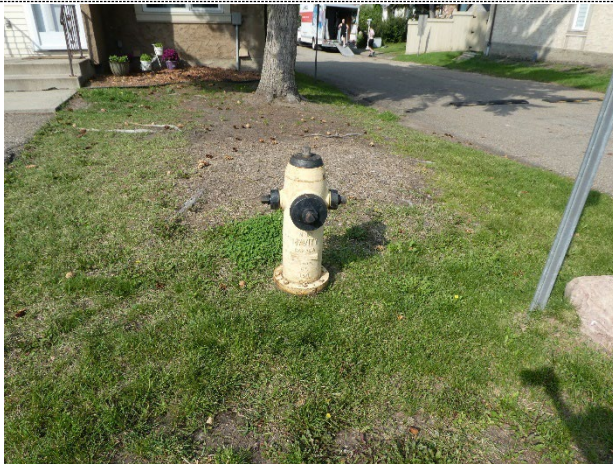
Fire hydrant
